TENNESSEE VALLEY AUTHORITY

KINGSTON FOSSIL PLANT

ANNUAL ASH POND DIKE
STABILITY INSPECTION
2008

Prepared by: Jamey Dotson
Date: February 15, 2008

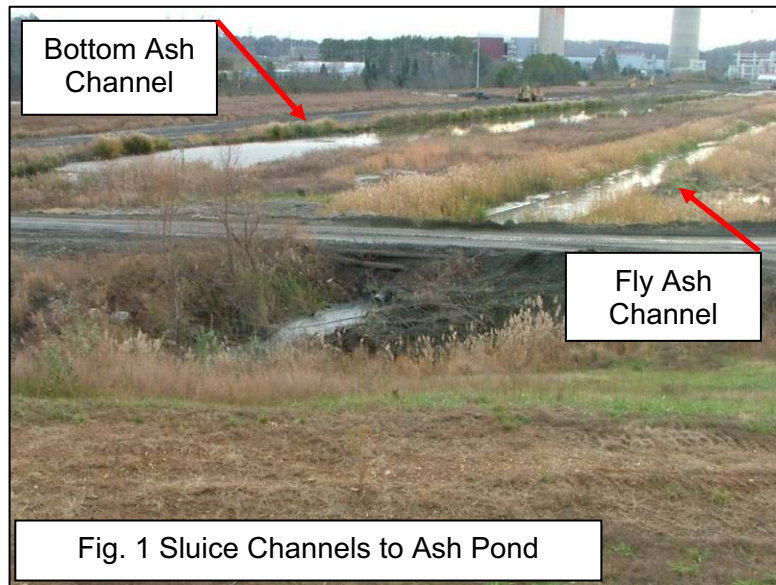
Fly ash is sluiced into an adjacent channel to the bottom ash channel where it flows into the main ash pond. The fly ash channel was cleared of vegetation last year. Both channels flow northeast into the active ash pond. See Figure 1 and drawing API 2008.

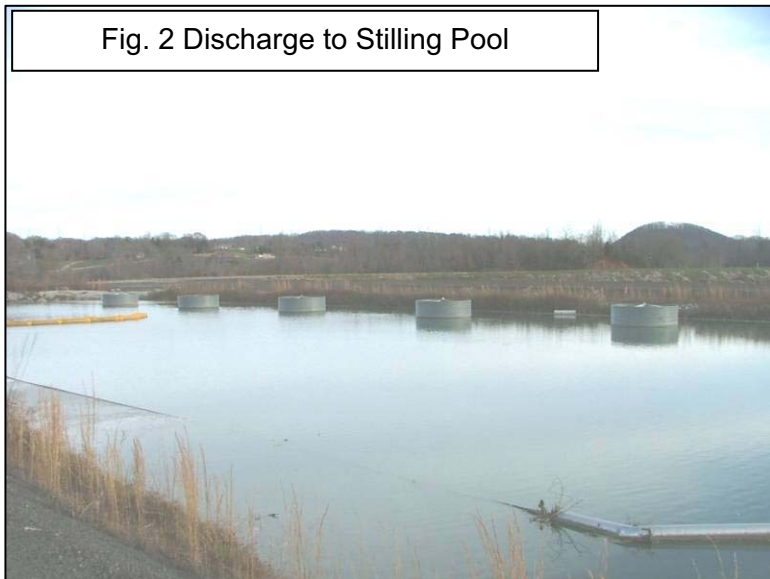
Sluice water flows from the active ash pond into the stilling pond through the five spillways constructed in 2005 (see Figure 2), as part of a project to allow more accurate accounting of free water volume. The old plant constructed spillway (Kennedy Weir) was taken out of operation at the same time. From the stilling pool, the water discharges into the plant intake channel via six standard spillways equipped with discharge diffusers constructed in November 2003. Many of these structures have vegetation and brush growing inside them, which needs to be removed.

- Remove vegetation growing inside spillway structures.
- Investigate the use of spraying to inhibit vegetation growth on the interior dikes of the stilling pond.

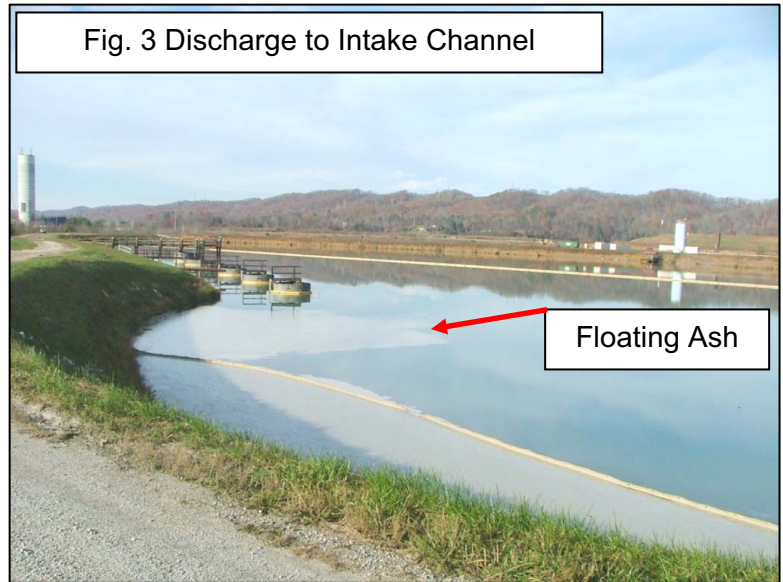
Large amounts of floating ash have been contained within floating skimmer booms (two inside both the active ash pond and the stilling pool). This ash should be removed in order to prevent an accidental release. Some of this ash has breached the booms and is near the discharge structures. See Figure 3. The seeps along the toe of Dike C and below the toe of the dike along the intake channel, known since the early 1980s were not visible during this inspection.

- Remove ash floating on the surface of the ash and stilling ponds.
- Repair rutting in the access and dike roadways. Fill with bottom ash and regrade as required to promote drainage.

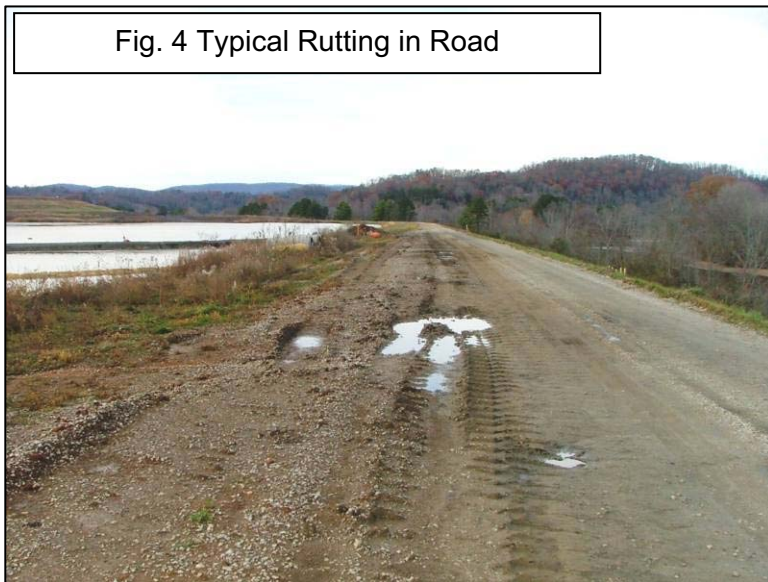
Some of the dike roads exhibit areas of rutting, see Figure 4. This photo is typical of the conditions of the roads, although it does not appear to be a significant problem

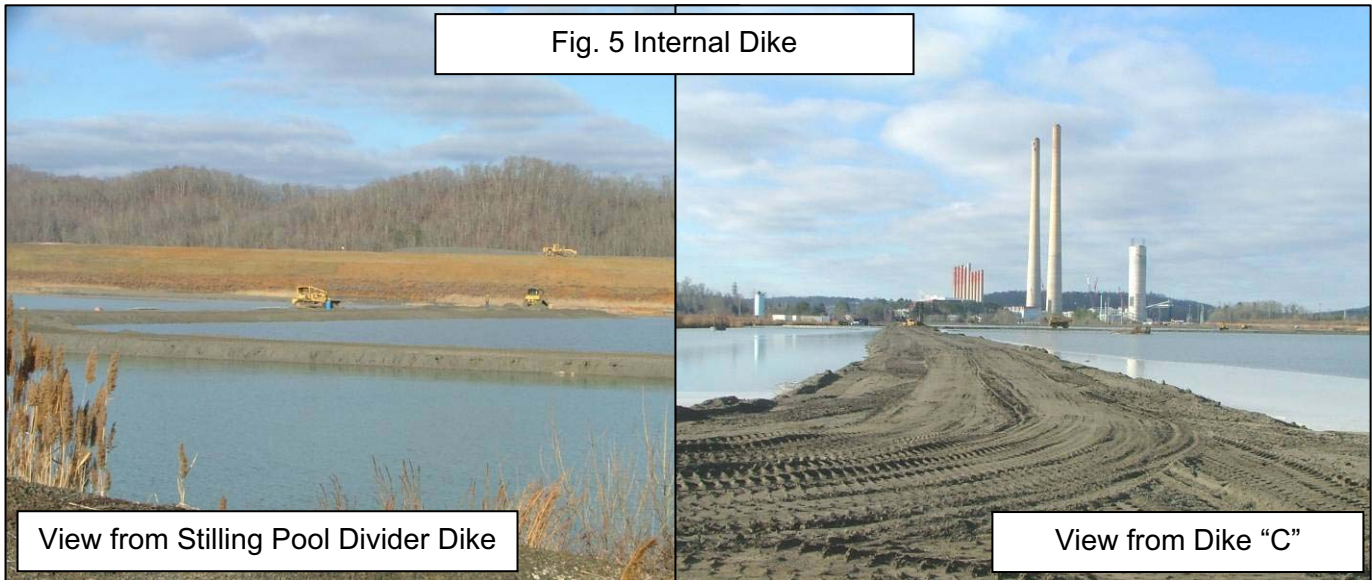
Construction of an internal divider dike inside the active ash disposal area is currently underway. The divider dikes will be constructed to build a base of fly ash for a dredge cell expansion, which will eventually cover approximately half of the existing main ash pond. See Figure 5.

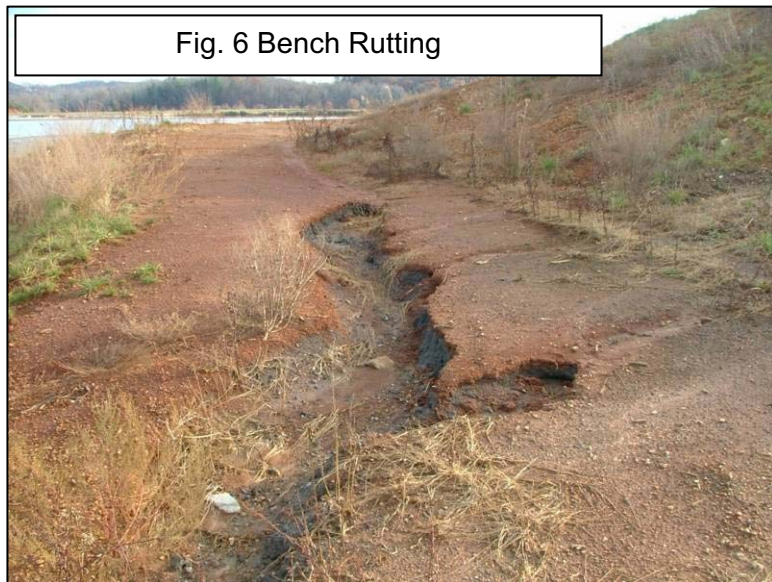
The interim dredge cell capacity has been depleted; however decant water from the raised dredge cells flows through the interim cell to the main ash pond. Water flow into the interim cell is essential for dust control. The divider dike between this cell and the active pond appeared to be in stable condition with some bench rutting and poor vegetation. There was one section of standing water approximately 100 feet in length. As much as practical, these areas should be graded so they will drain, even if slowly. Wheel ruts that hold water should be filled with bottom ash and covered with stone if they are in a road. See Figures 6 and 7 (next page).

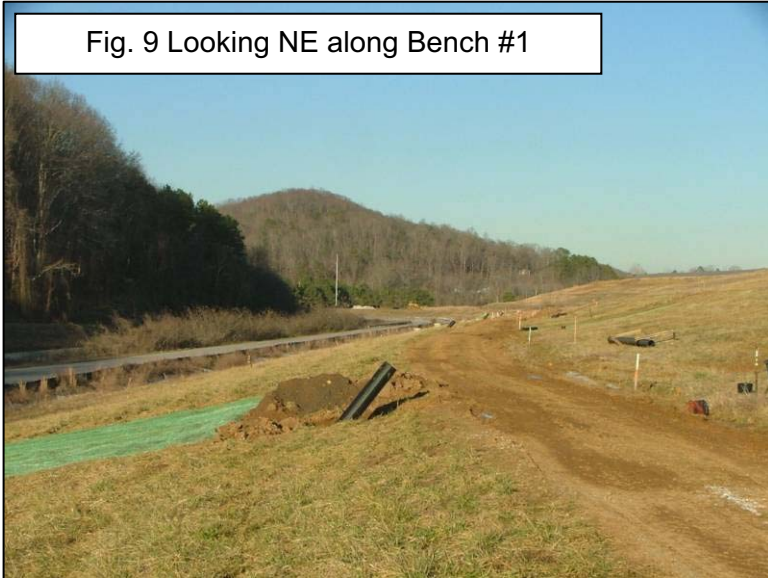
the poor bench drainage. The lower benches will be re-graded to provide positive drainage to a series of catch basins which will divert the water collected to the lower drainage ditch. Construction is currently underway to install surface drainage repairs, (See Figure 8, Figure 9 (next page), and Drawings 10WXXX-1 through -10 for details). In addition to these repairs, outlets are being installed on the old dewatering wells to allow personnel to relieve some of the water in these wells. The water drained will flow to the riprap channel along Swan Pond Road.

Fig. 9 Looking NE along Bench #1

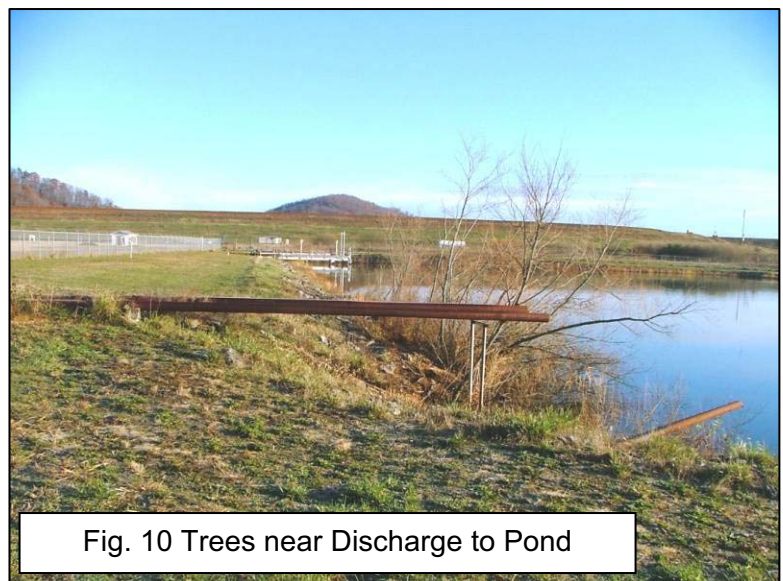
The chemical treatment ponds (iron and copper) are located southwest of the active ash pond. Both ponds were excavated and have no exterior slopes. The internal dike slopes are covered with riprap. These slopes were in good condition with a few trees present. See Figure 10. Sediment in the ponds was tested in FY 2004 and found to be non-hazardous. It appeared that some maintenance had been recently performed at one of the pond platforms. Old gaskets were on the ground and there was a new pipe flange and hardware. The platform at the smaller pond was missing a pump.

Fig. 10 Trees near Discharge to Pond

- Remove trees from the slopes of the dikes. Mowing at least twice a year is recommended to control the size of the trees. Preventing the trees from getting larger than 1" in diameter at the ground is preferred. Any trees larger than 3" in diameter at the base must be pulled from the dikes, roots and all. Repair and reseed the damaged area.

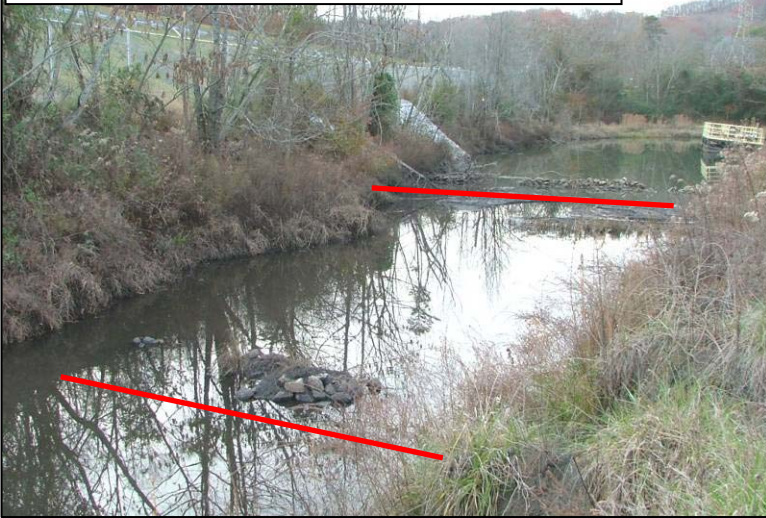
Fig. 11 Breached Check Dams

storage volume contained coal yard sediment. The above figure shows rock check dams built to keep the coal fines away from the pumps. The check dams appear to have been breached, allowing suspended solids to reach the pumps. TVA drawing 10W225-2 (attached as API 2008-2) shows the pond and its intended bottom contours.

- Dredge the Coal Yard Drainage Basin to restore its design contours and protect the pumps from further damage. There is an estimated 2,800+ cubic yards of sediment in the original pond and an extra 3,400+ cubic yards in the "V" section that needs to be removed as soon as reasonable. See the attached copy of 10W225-2. Estimated at \$55,000, depending on haul distance.

- Continue intermittent dredging into the interim dredge cell to inhibit fugitive dusting.
- Re-establish riprap check dams in the coal yard drainage basin to prevent solids away from the pumps.

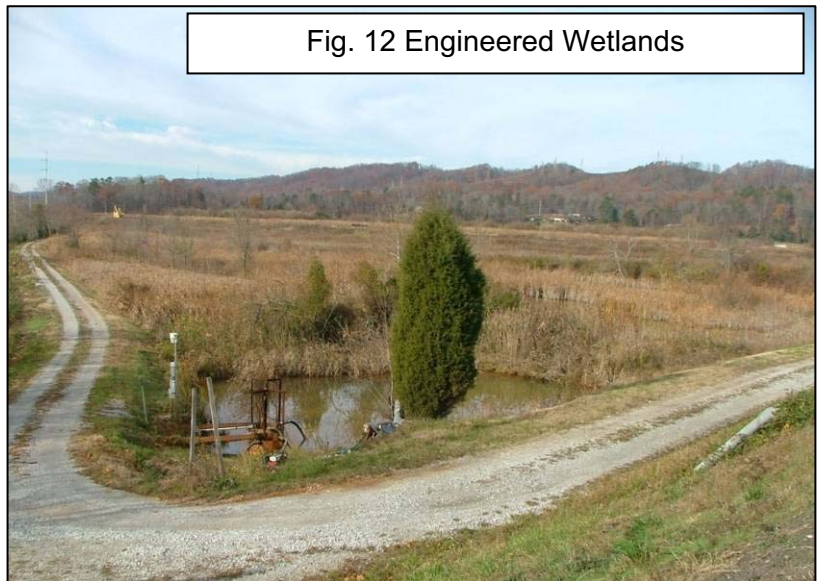
The engineered wetlands along the southwest dike receive seepage that collects in the anoxic limestone drain below the bottom ash trench. The wetland appeared to be functioning, but the discharge is still pumped via two pumps to the ash pond, see Figure 12.

The water levels in the pump structures were at different levels at the time of inspection. There were several trees varying in size growing on the interior dikes of the ponds.

Fig. 12 Engineered Wetlands
