**RAILWAY INVESTIGATION REPORT  
R13D0054**

**RUNAWAY AND MAIN-TRACK DERAILMENT**

**MONTREAL, MAINE & ATLANTIC RAILWAY  
FREIGHT TRAIN MMA-002  
MILE 0.23, SHERBROOKE SUBDIVISION  
LAC-MÉGANTIC, QUEBEC  
06 JULY 2013**

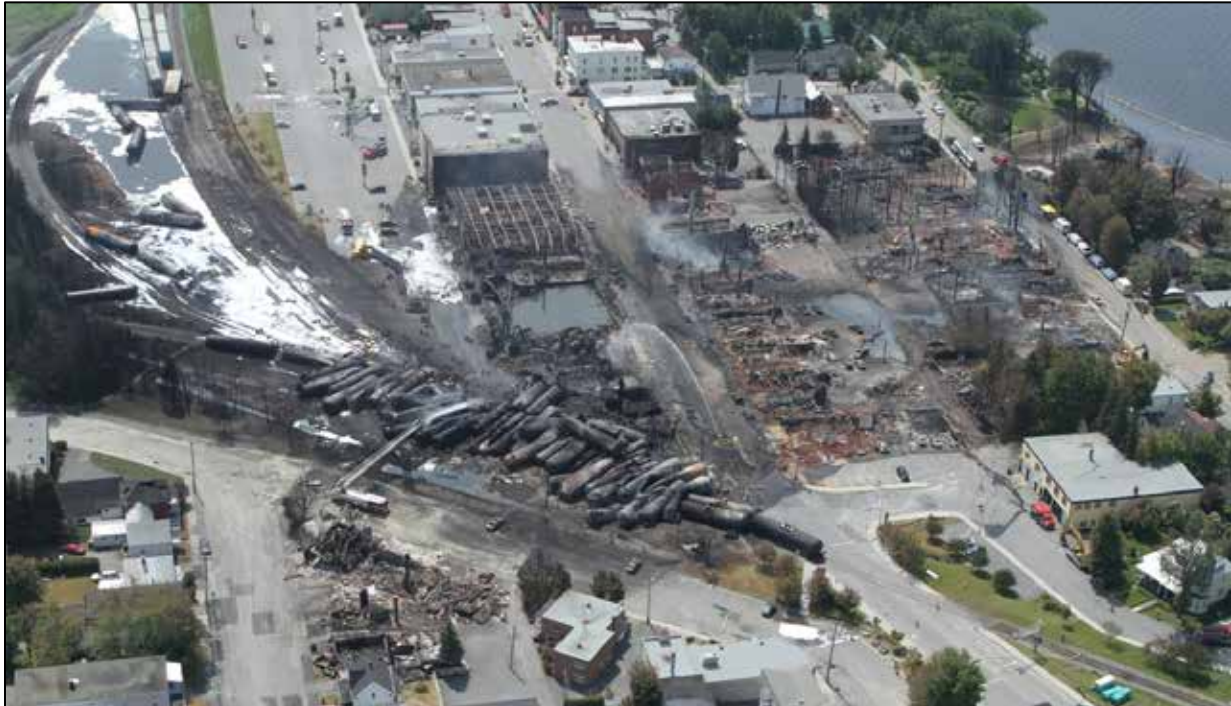
Photo 1. The Lac-Mégantic derailment site following the accident

As a result of the derailment and the ensuing fires and explosions, 47 people died, and about 2000 people were evacuated. Forty buildings and 53 vehicles were destroyed (Photo 1).

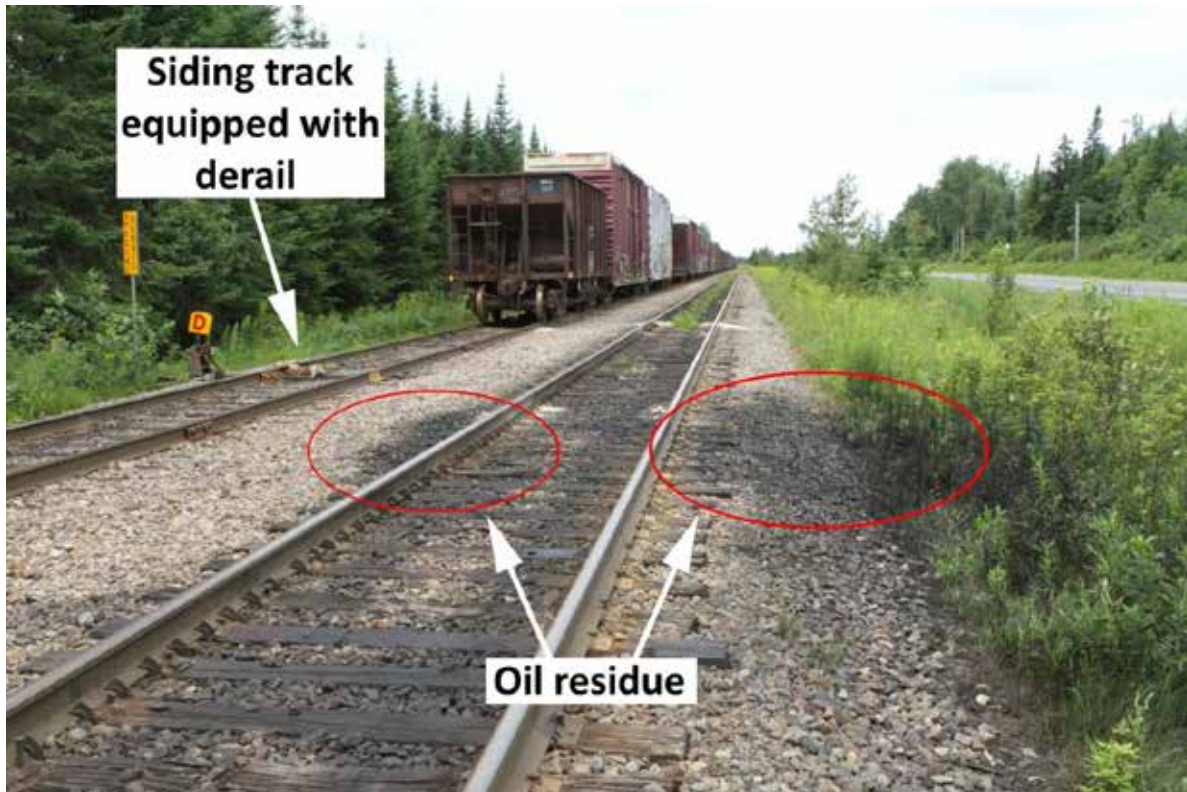
Photo 3. Oil residue on the ground and vegetation at Nantes. Note derail on adjacent siding track on left (view westward from the location where the lead locomotive was parked on the main track).

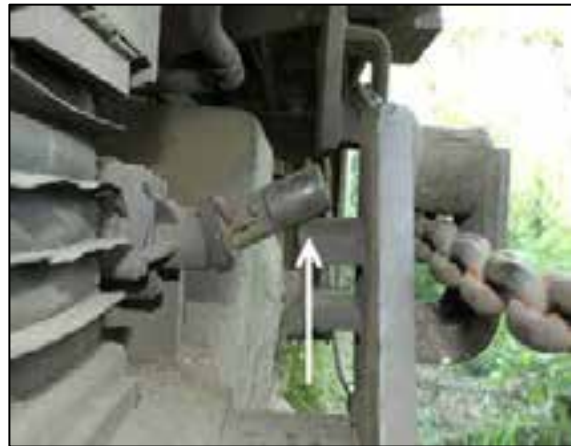
Photo 11. As the hand brake is tightened, the upward movement is intended to activate the release mechanism on the QRB valve.

The QRB valve on the second locomotive (MMA 5026) did not trip to exhaust brake cylinder air when tested. An examination of the valve showed wear and damage to the QRB valve's lifter and inside surface of the retaining disc. In addition, the examination showed that non-standard repairs had been applied to the valve's release mechanism in an attempt to keep the valve working.

If the QRB valve does not trip, the hand brakes will not provide any braking effort. To ensure that the hand brakes remain operational on these locomotives, MMA issued *Summary Operating Bulletin 2-276*, which stated in part:

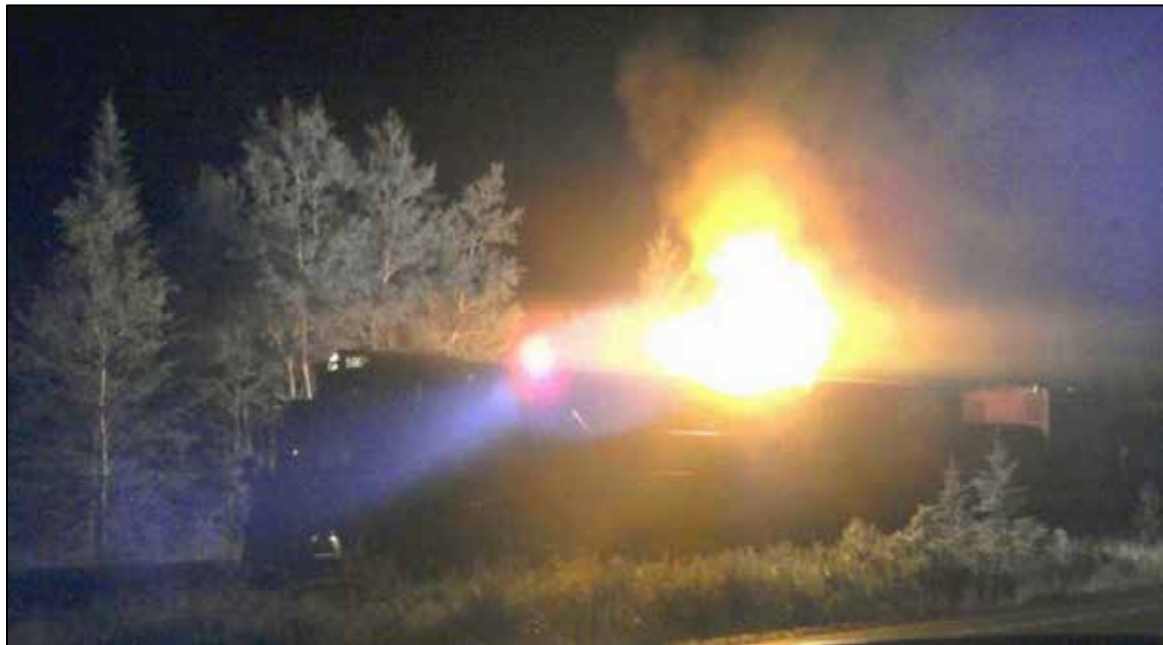
Photo 13. Locomotive fire at Nantes (photo: Nancy Cameron)

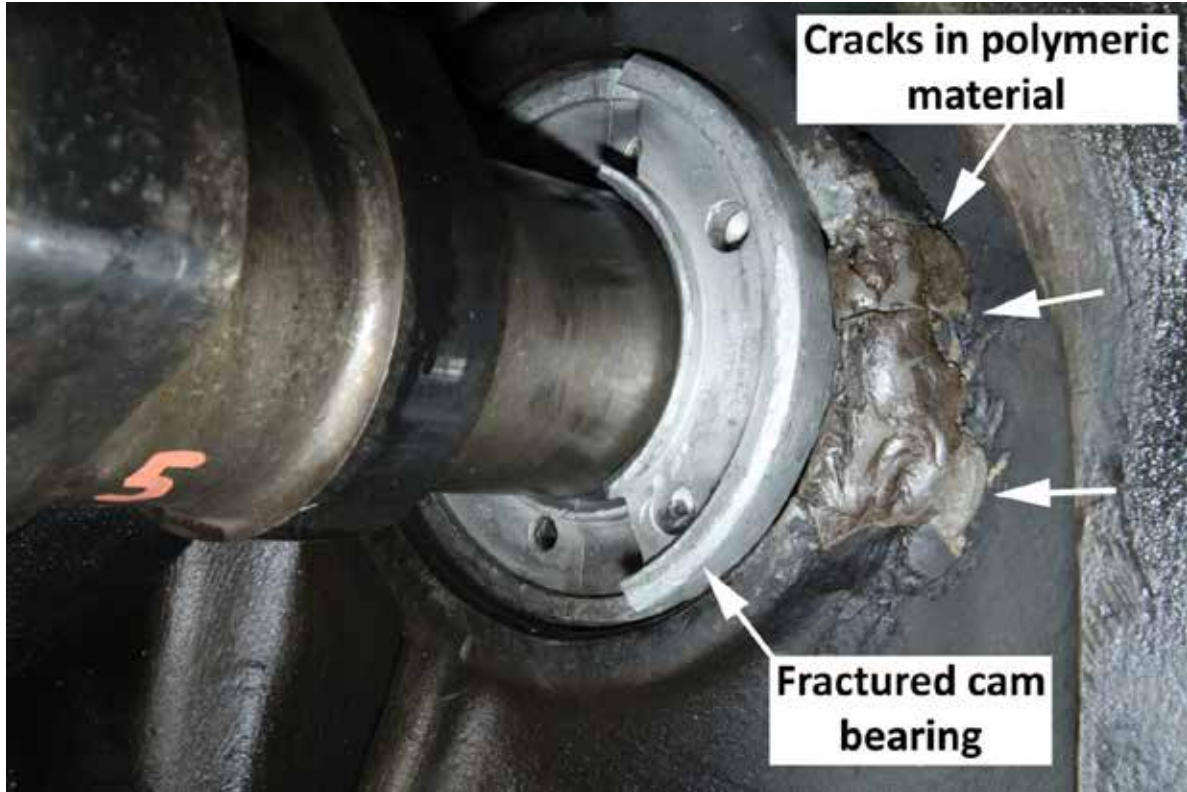
Following the accident, the locomotive consist was moved from Lac-Mégantic to a maintenance facility in Saint John for examination. A partial engine teardown of MMA 5017 was conducted (see Engineering Laboratory Report LP181/2013 for complete details). It was determined that the cam bearing had fractured when the mounting bolt was over-tightened after the cam bearing had been installed as part of a non-standard repair to the engine block. This temporary repair had been performed using a polymeric material, which did not have the strength and durability required for this use (Photo 14). Failure of the cam bearing reduced the engine oil supply to the valve train at the top of the associated power assembly. The decreased lubrication led to valve damage and eventually to a punctured piston crown. The damaged valves and piston crown allowed engine oil to flow into the cylinder and the intake and exhaust manifolds. Some of the engine oil collected in the body of the turbocharger. The engine fire later occurred in the exhaust stack due to the build-up and ignition of engine oil in the body of the turbocharger.

Photo 14. Polymeric material applied to cam bearing bore and fractured cam bearing

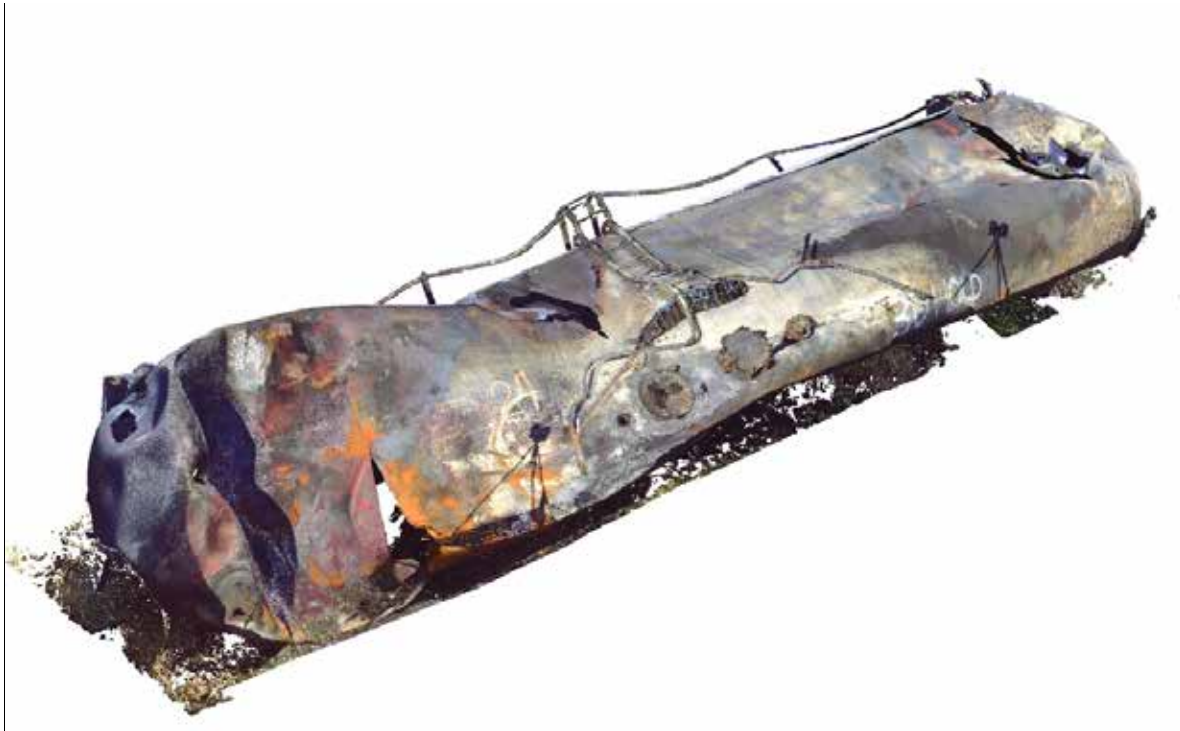
Photo 16. 3D laser scan of badly deformed tank

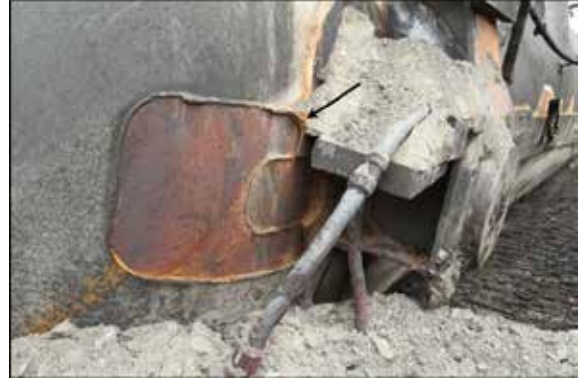
Photo 18. Damaged stub sill

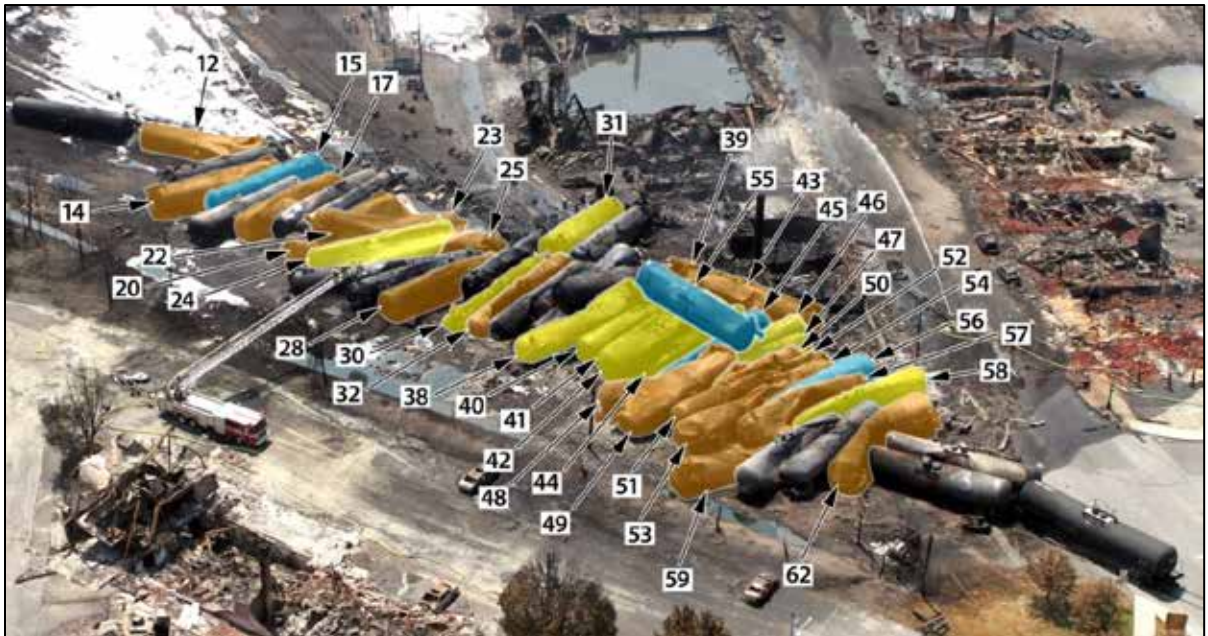
More than half of the tank cars (37 cars) released product due to impact damage to their shells (Photo 19). Other tank car shell damage included deformed/dented shells with no breach, as well as breaches due to thermal tears.

Photo 19. Tank cars with breaches to their shells (colour indicates relative size of breach: orange = large, yellow = medium, blue = small). The relative size of the breaches is also identified in Appendix B.

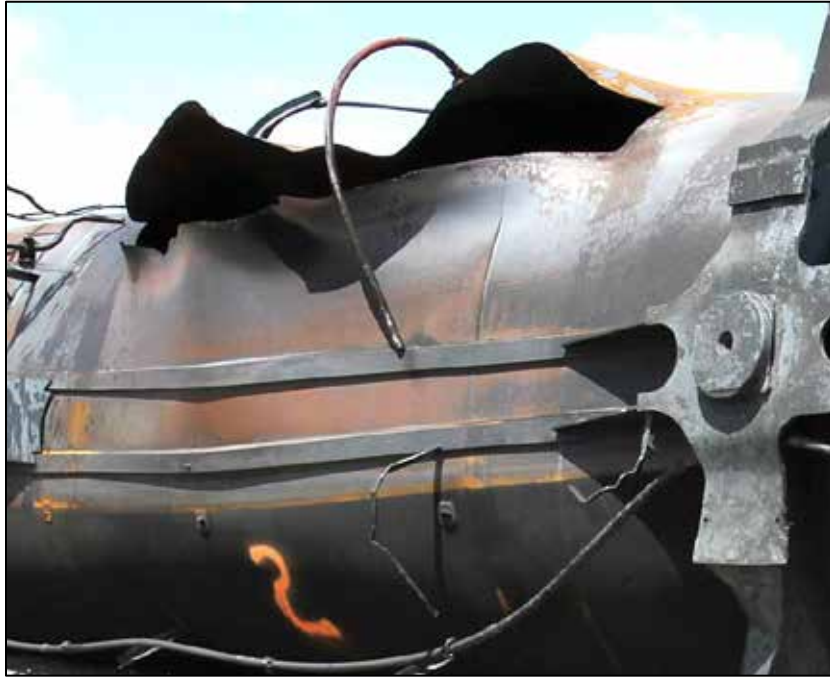
Photo 27. Thermal tear

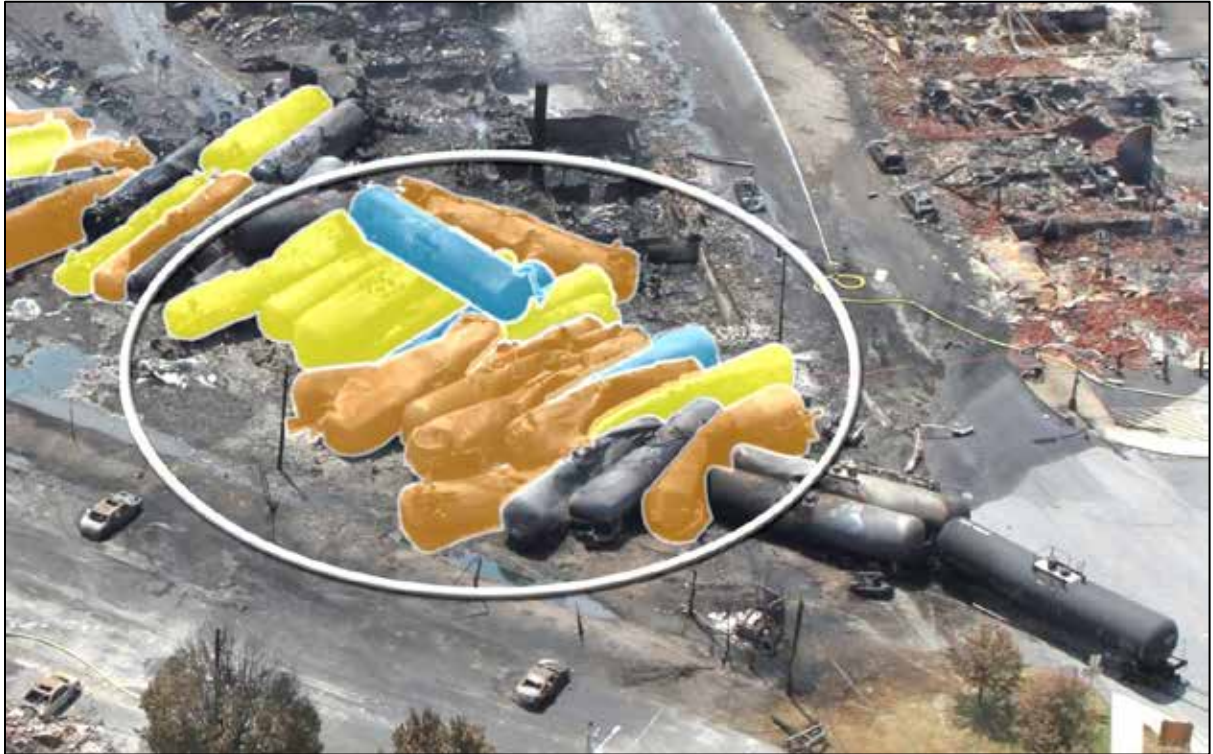
Photo 30. Concentration of large (orange) and medium (yellow) breaches toward the end of the derailment

About half of the cars with large breaches were clustered toward the end of the derailment. These cars would have encountered more severe derailment conditions than the conditions experienced by the cars located toward the front of the train, due to the large pileup ahead of them. This pileup likely acted as a wall for the cars derailing toward the end of the train. These highly constrained derailment conditions caused large-scale buckling and extreme tank deformations (that is, plastic collapse), which resulted in large shell ruptures. These cars derailed at a slower speed, and came to rest perpendicular to the track. Their thin wall construction (7/16 inch), as well as the absence of jackets, did not provide sufficient protection from the derailment forces. Consequently, large tank shell breaches occurred in a short period of time on about 1/3 of the derailed tank cars, which resulted in the rapid release of large quantities of petroleum crude oil.
