TENNESSEE VALLEY AUTHORITY

KINGSTON FOSSIL PLANT

ANNUAL ASH POND DIKE
STABILITY INSPECTION
2008

Prepared by: Jamey Dotson
Date: February 15, 2008

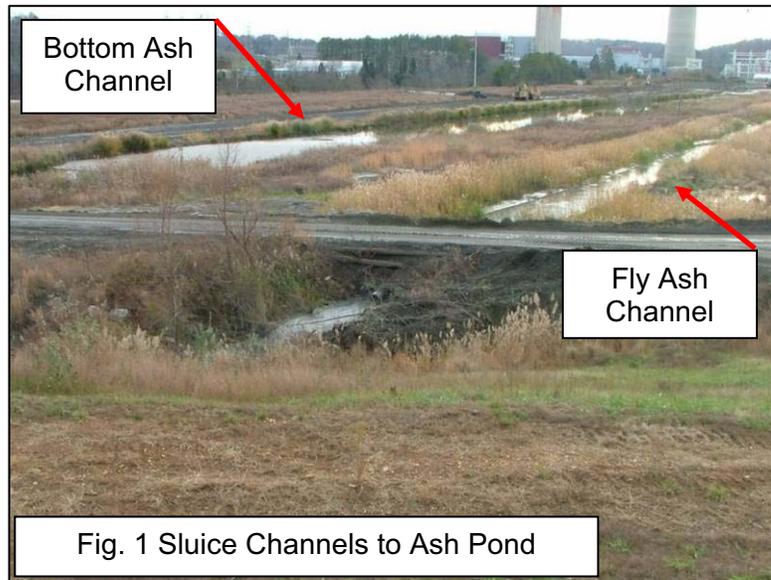
Fly ash is sluiced into an adjacent channel to the bottom ash channel where it flows into the main ash pond. The fly ash channel was cleared of vegetation last year. Both channels flow northeast into the active ash pond. See Figure 1 and drawing API 2008.

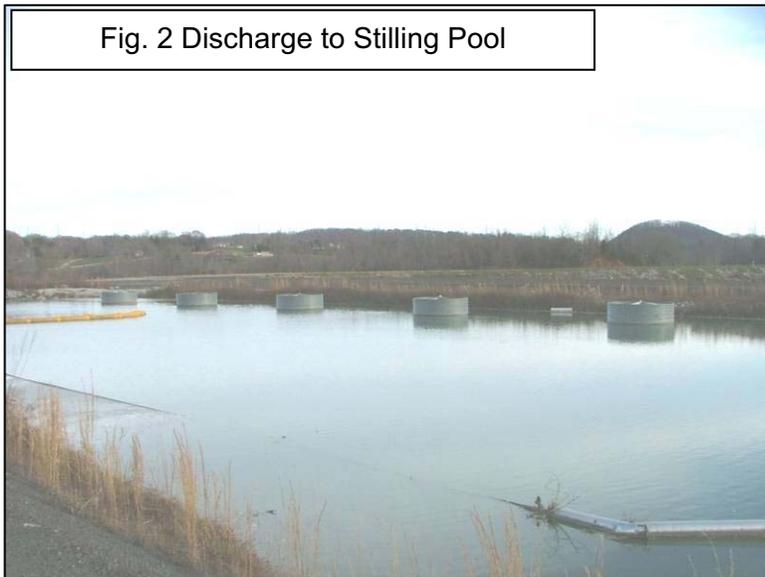
Sluice water flows from the active ash pond into the stilling pond through the five spillways constructed in 2005 (see Figure 2), as part of a project to allow more accurate accounting of free water volume. The old plant constructed spillway (Kennedy Weir) was taken out of operation at the same time. From the stilling pool, the water discharges into the plant intake channel via six standard spillways equipped with discharge diffusers constructed in November 2003. Many of these structures have vegetation and brush growing inside them, which needs to be removed.

- Remove vegetation growing inside spillway structures.
- Investigate the use of spraying to inhibit vegetation growth on the interior dikes of the stilling pond.

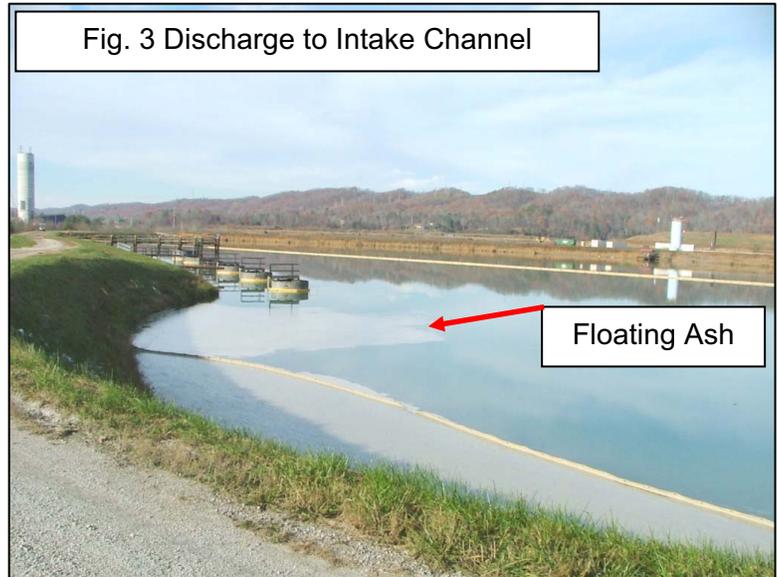
Large amounts of floating ash have been contained within floating skimmer booms (two inside both the active ash pond and the stilling pool). This ash should be removed in order to prevent an accidental release. Some of this ash has breached the booms and is near the discharge structures. See Figure 3. The seeps along the toe of Dike C and below the toe of the dike along the intake channel, known since the early 1980s were not visible during this inspection.

- Remove ash floating on the surface of the ash and stilling ponds.
- Repair rutting in the access and dike roadways. Fill with bottom ash and regrade as required to promote drainage.

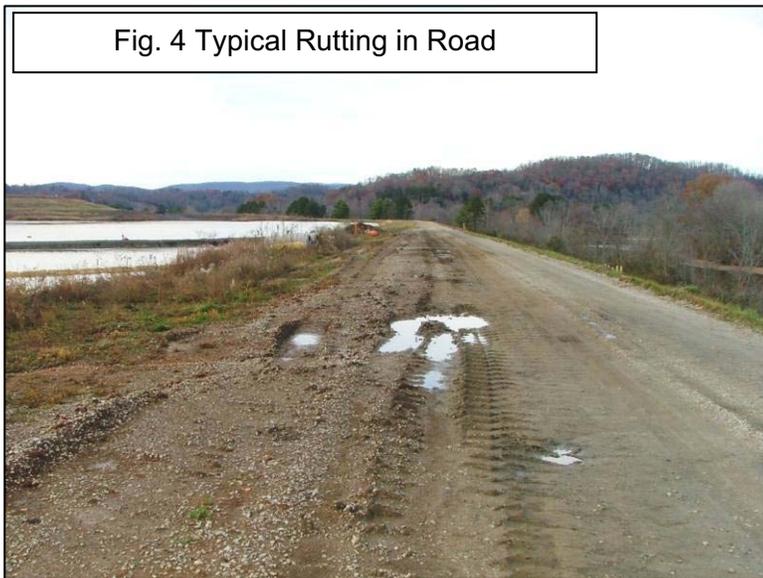
Some of the dike roads exhibit areas of rutting, see Figure 4. This photo is typical of the conditions of the roads, although it does not appear to be a significant problem

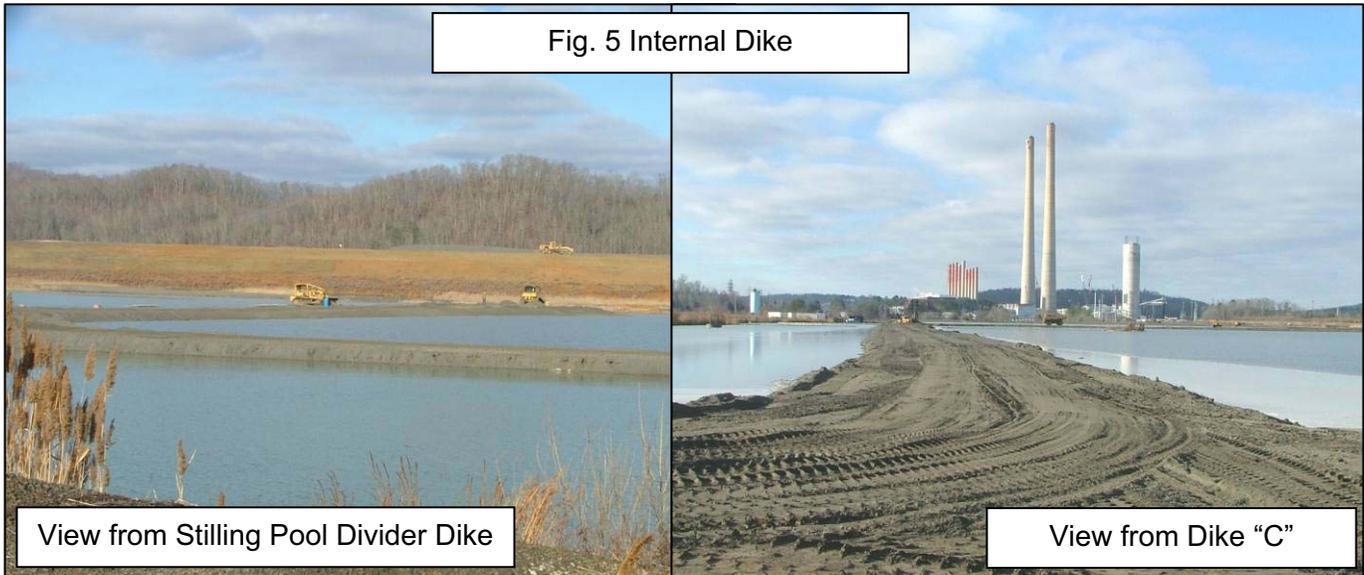
Construction of an internal divider dike inside the active ash disposal area is currently underway. The divider dikes will be constructed to build a base of fly ash for a dredge cell expansion, which will eventually cover approximately half of the existing main ash pond. See Figure 5.

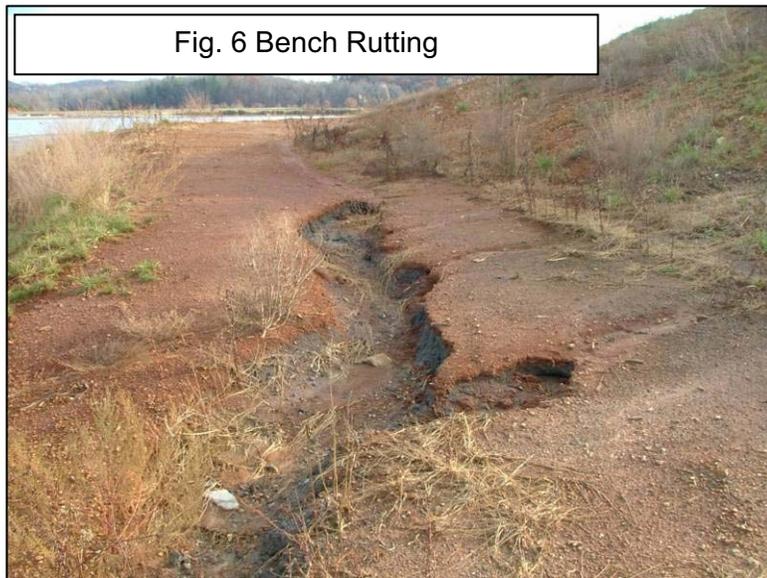
The interim dredge cell capacity has been depleted; however decant water from the raised dredge cells flows through the interim cell to the main ash pond. Water flow into the interim cell is essential for dust control. The divider dike between this cell and the active pond appeared to be in stable condition with some bench rutting and poor vegetation. There was one section of standing water approximately 100 feet in length. As much as practical, these areas should be graded so they will drain, even if slowly. Wheel ruts that hold water should be filled with bottom ash and covered with stone if they are in a road. See Figures 6 and 7 (next page).

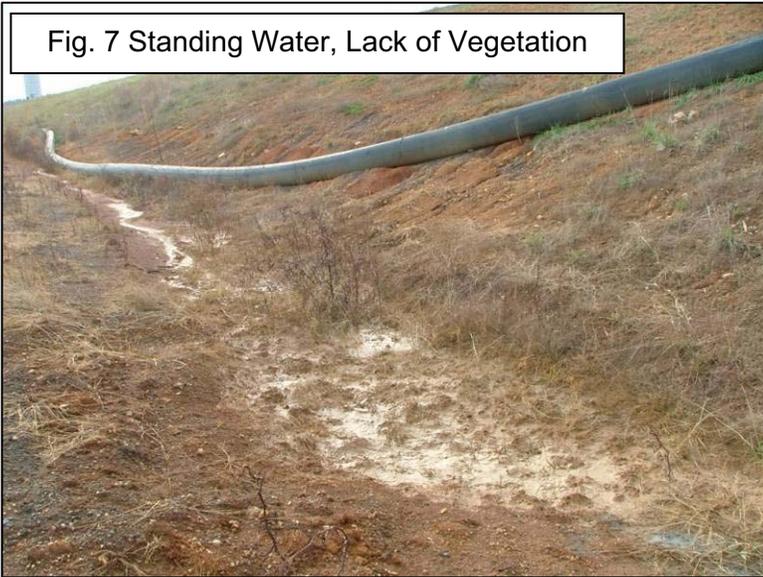
Fig. 7 Standing Water, Lack of Vegetation

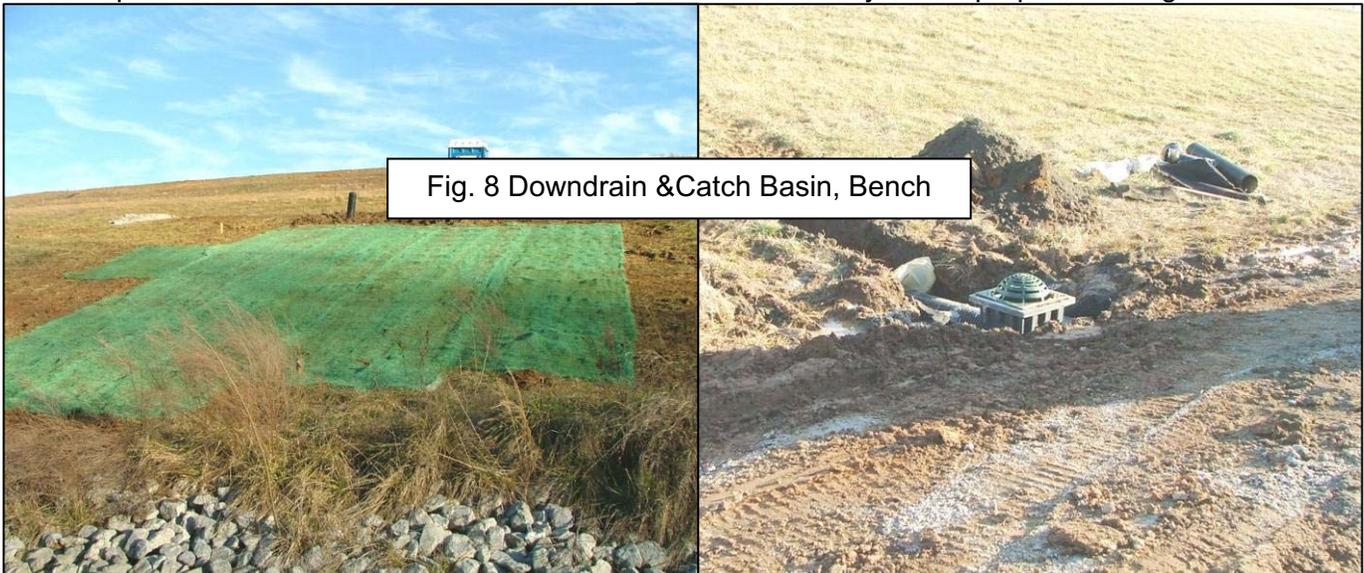
Fig. 8 Downdrain & Catch Basin, Bench

the poor bench drainage. The lower benches will be re-graded to provide positive drainage to a series of catch basins which will divert the water collected to the lower drainage ditch. Construction is currently underway to install surface drainage repairs, (See Figure 8, Figure 9 (next page), and Drawings 10WXXX-1 through -10 for details). In addition to these repairs, outlets are being installed on the old dewatering wells to allow personnel to relieve some of the water in these wells. The water drained will flow to the riprap channel along Swan Pond Road.

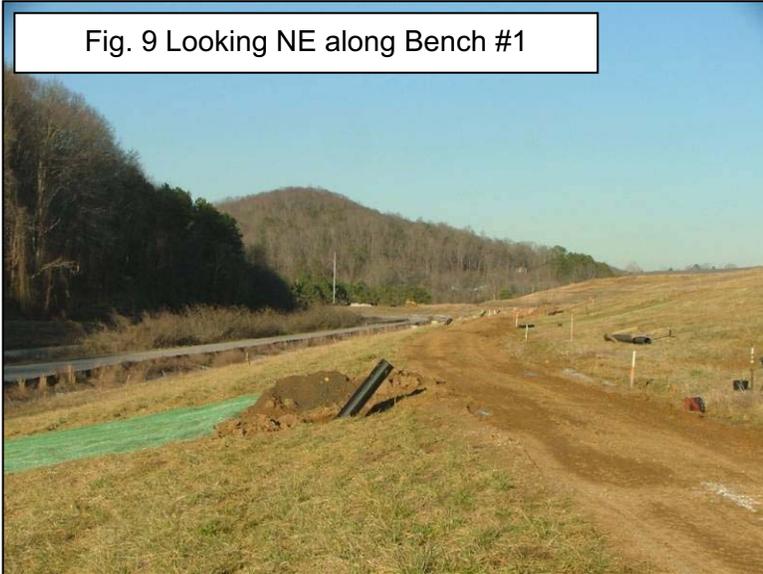
Fig. 9 Looking NE along Bench #1

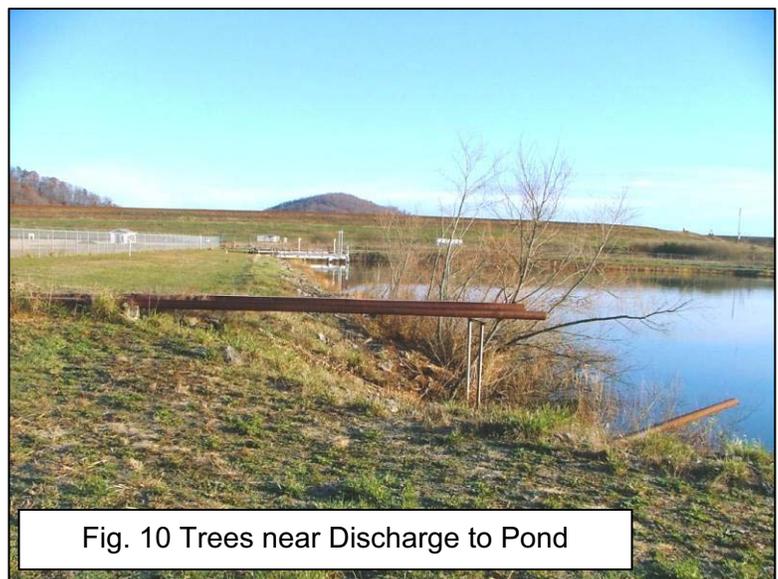
The chemical treatment ponds (iron and copper) are located southwest of the active ash pond. Both ponds were excavated and have no exterior slopes. The internal dike slopes are covered with riprap. These slopes were in good condition with a few trees present. See Figure 10. Sediment in the ponds was tested in FY 2004 and found to be non-hazardous. It appeared that some maintenance had been recently performed at one of the pond platforms. Old gaskets were on the ground and there was a new pipe flange and hardware. The platform at the smaller pond was missing a pump.

Fig. 10 Trees near Discharge to Pond

- Remove trees from the slopes of the dikes. Mowing at least twice a year is recommended to control the size of the trees. Preventing the trees from getting larger than 1" in diameter at the ground is preferred. Any trees larger than 3" in diameter at the base must be pulled from the dikes, roots and all. Repair and reseed the damaged area.

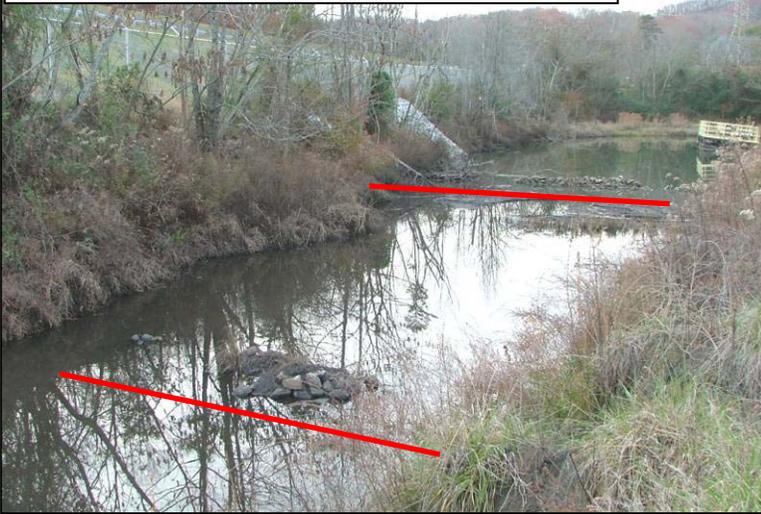
Fig. 11 Breached Check Dams

storage volume contained coal yard sediment. The above figure shows rock check dams built to keep the coal fines away from the pumps. The check dams appear to have been breached, allowing suspended solids to reach the pumps. TVA drawing 10W225-2 (attached as API 2008-2) shows the pond and its intended bottom contours.

- Continue intermittent dredging into the interim dredge cell to inhibit fugitive dusting.
- Re-establish riprap check dams in the coal yard drainage basin to prevent solids away from the pumps.

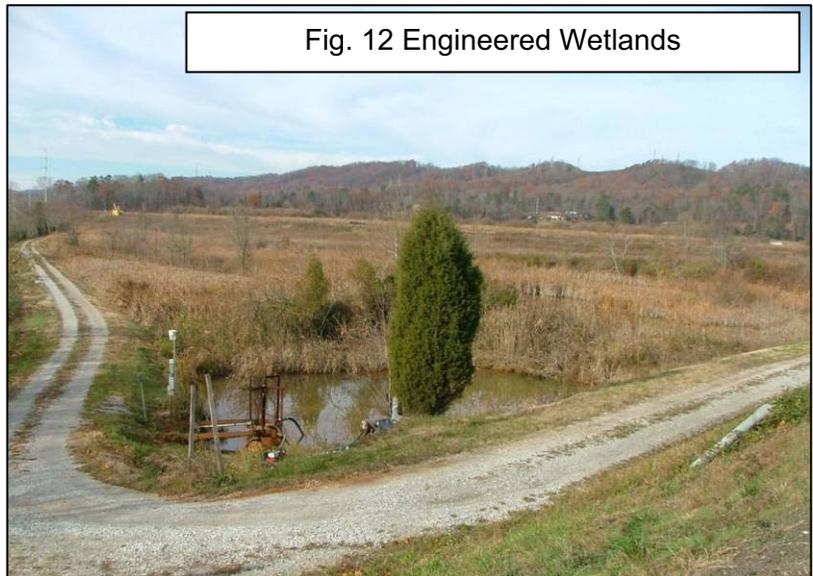
The engineered wetlands along the southwest dike receive seepage that collects in the anoxic limestone drain below the bottom ash trench. The wetland appeared to be functioning, but the discharge is still pumped via two pumps to the ash pond, see Figure 12.

The water levels in the pump structures were at different levels at the time of inspection. There were several trees varying in size growing on the interior dikes of the ponds.

Fig. 12 Engineered Wetlands
