October 8, 2018

Champlain Towers South  
8777 Collins Avenue  
Surfside, FL 33154

**Re: Champlain Towers South Condominium  
Structural Field Survey Report  
MC Job# 18217**

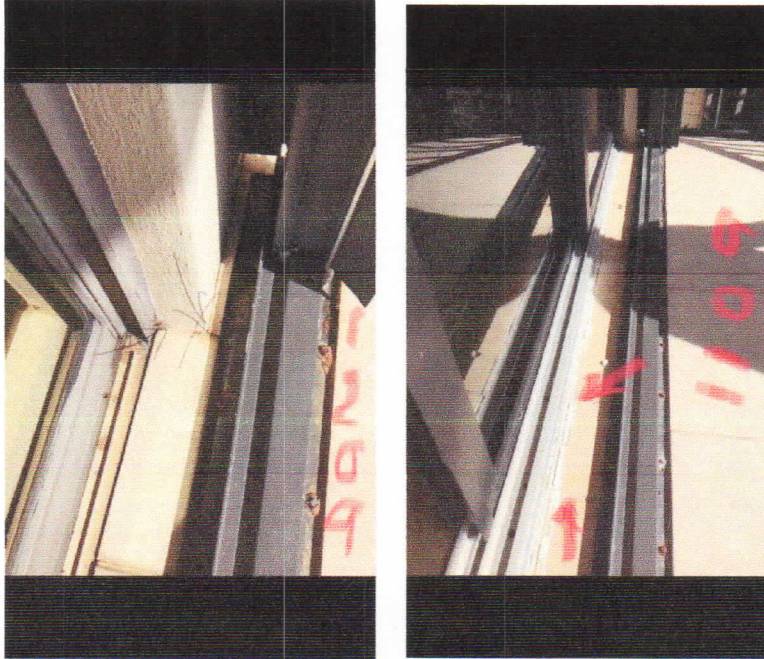
- A. MC understands some unit owners have complained of flooding into the interior space of their unit during a hurricane event. MC has concluded that this infiltration is occurring through the balcony sliding glass doors & windows due to the lack of proper flashing at the sill of these doors & windows and deteriorated exterior perimeter sealant between the window/door frames and masonry/concrete walls. MC recommends that the exterior sealant be removed / replaced at the sliding glass door & window perimeter to assist in providing a water-tight condition. Unfortunately, the new sliding doors in unit 209 and above were not installed properly and were fabricated too tall to allow the base flashing to be properly installed, so these unit owners have no choice but to discard the newly purchased doors and have them completely refabricated.

Figure A1: Exterior sealant past its serviceable lifespan at sealant between the window/door frames and masonry/concrete walls & balcony floors

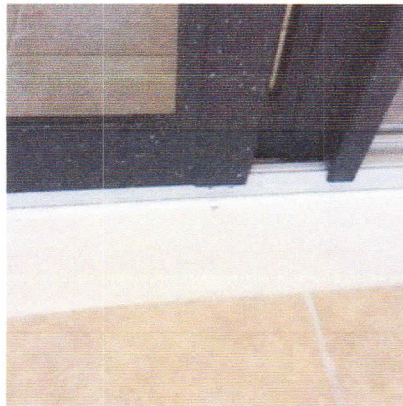
Figure A2: Newly installed sliding door at unit 209 that was not properly flashed

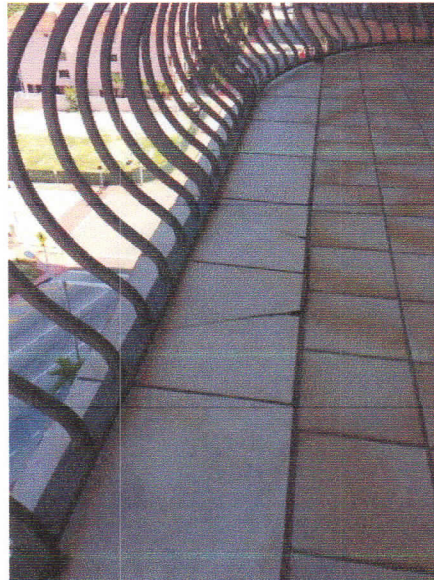
- B. MC observed that the majority of the balconies were furnished with tile or some other floor covering by choice of the tenant, making it impossible to observe the condition of the topside of the balcony slabs. Several instances were noted where balcony tile was damaged, such as in Unit 1008. Based on MC experience, cracked tile usually means structural damage exists to the balcony slab that must be repaired per the requirements of the International Concrete Repair Institute (ICRI) prior to the installation of a pedestrian waterproofing membrane.

Figure B: Damaged balcony tile that must be removed to fix structural damage

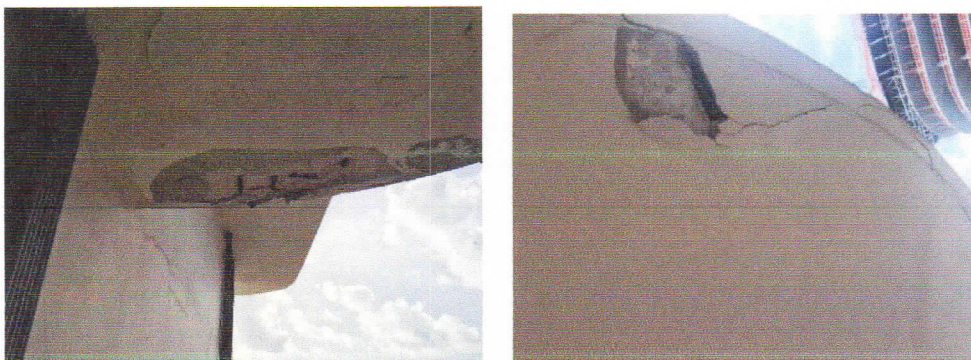
- C. MC found it fairly typical that the concrete slab edges of the balconies are experiencing concrete spalling or cracking. MC sees this as a common source of water infiltration and a main cause of the commonly found, sub-surface deterioration at the exterior soffits under the railings. MC requires that the balcony slab edges be further investigated and repaired in accordance with the recommendations of the ICRI to prevent future water penetration.

Figure C: Concrete spall at balcony slab edge in units 1008 & 211

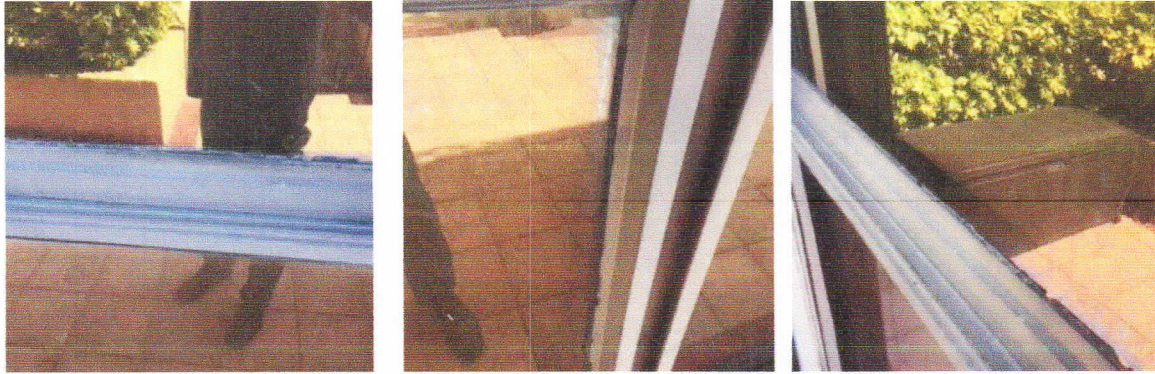
- F. It was brought to MC's attention that several units are experiencing water infiltration through the window frames and glazing as the windows are near the end of their functional lifespan. It is recommended that the window frame glazing (metal to glass), and perimeter sealant (metal to metal or metal to masonry/concrete) be removed and replaced for the entirety of the building to reduce future water penetration and minimize damage during hurricane events. MC recommends that the BOD strongly consider the replacement of all exterior windows and doors with impact resistant units.

Figure F: Exterior sealant at window frame that has aged past its serviceable lifespan

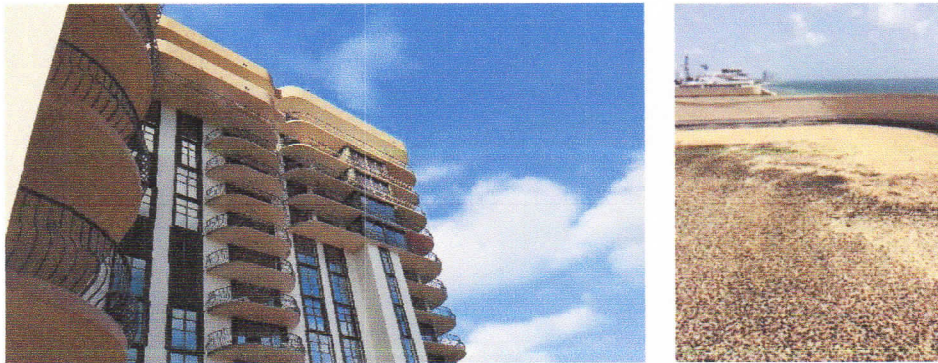
- H. MC observed the non-existence of window washing / suspension hooks that should have been installed face-mounted to the underside of the top-level balconies and spread throughout the roof of this building structure. This failure to have suspension hooks is a violation of the present-day **Occupational Safety and Health Administration (OSHA) Rules and Regulations 29 CFR Part 1910 "Walking-Working Surfaces and Personal Protective Equipment (Fall Protection systems)"** requirements and **ANSI/IWCA I-14.1-2001 "Window Cleaning Safety Standard"**. MC recommends that new hooks be installed and waterproofed on the roof structural slab and underside of the top-level balcony slabs that meet the requirements of **OSHA 29 CFR Part 1926.502 "Fall Protection Systems Criteria and Practices"** and **ANSI/IWCA 1-14.1** prior to the commencement of façade and balcony restoration. Furthermore, MC recommends that our office meet with the contractor who is to perform the façade restoration work and the present window washing contractor so that the new fall protection system anchor quantity and location can be agreed upon to assure adequate anchor coverage for all future contractors who will be suspended on the exterior of the Champlain Towers South Condominium.

Figure H: No suspension hooks at the underside of the balconies and on the roof.

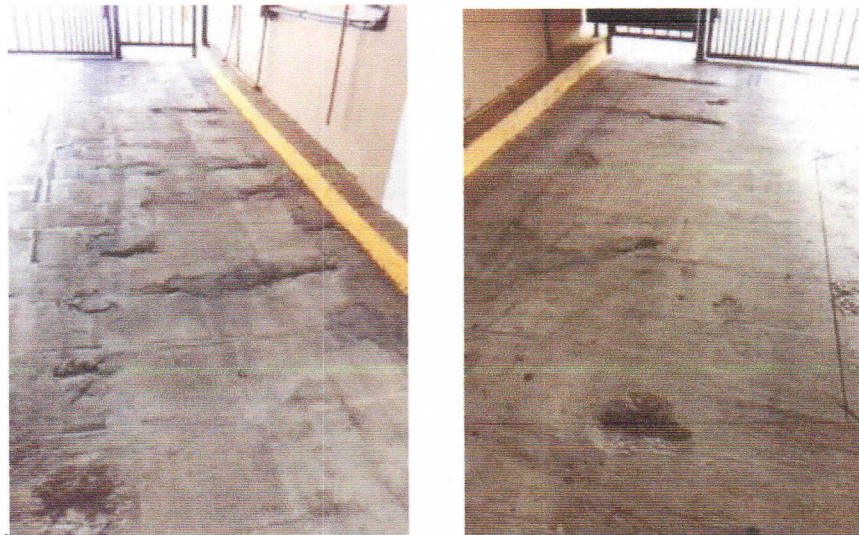
- J. Abundant cracking and spalling of varying degrees was observed in the concrete columns, beams, and walls. Several sizeable spalls were noted in both the topside of the entrance drive ramp and underside of the pool/entrance drive/planter slabs, which included instances with exposed, deteriorating rebar. Though some of this damage is minor, most of the concrete deterioration needs to be repaired in a timely fashion. All cracking and spalling located in the parking garage shall be repaired in accordance with the recommendations of ICRI.

Figure J2: Spalling with exposed steel reinforcement at topside of garage deck.
