Minnesota FACE Investigation 94MN01301

Construction Worker Dies After Falling From a Wind Turbine Tower

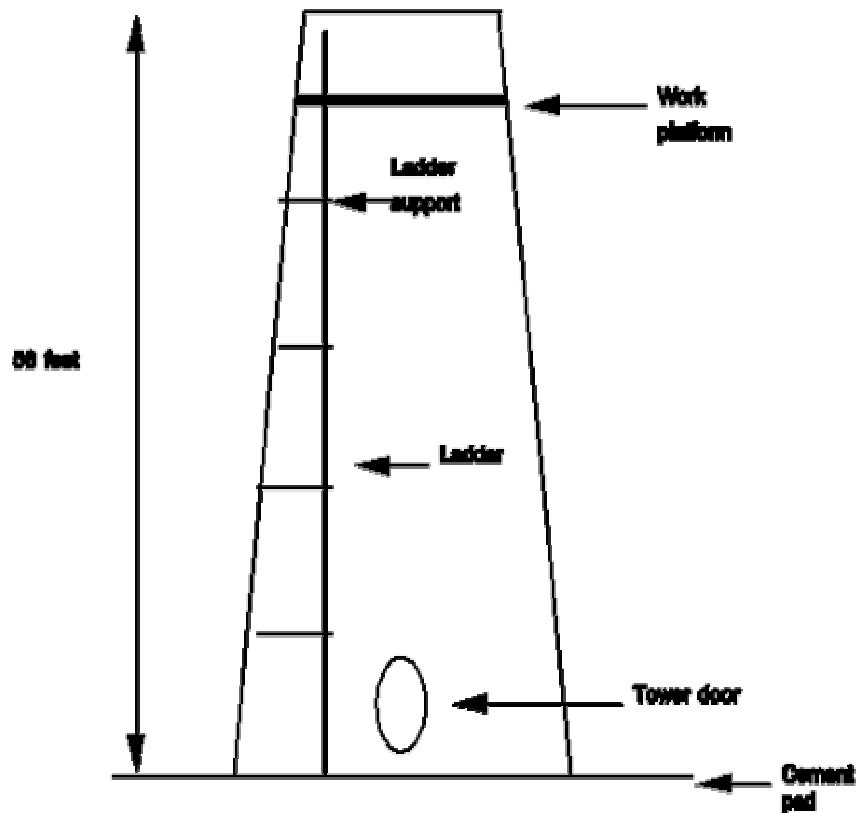
Figure 1.; Interior of bottom section of tower. Not to scale.

A 29-year-old male rigger (victim) died from injuries incurred after falling from a ladder inside a wind turbine tower under construction. He and two coworkers (Coworker 1 and Coworker 2) were bolting two tower sections together when the incident occurred. All were equipped with hard hats and safety belts with lanyards. The 120-foot tall tubular, tapered tower consisted of a bottom and top section, 56 and 64 feet tall, respectively. The bottom section, already bolted to a base concrete pad, was 11 feet in diameter. It tapered to 9 feet at the top, where the two sections were connected using 36 bolts. A door at the base of the bottom section allowed access to the inside of the tubular structure. Inside, a pre-installed metal ladder, secured with heavy steel supports at 12-inch intervals, ran along one side of the section. Workers climbed the ladder with the wall at their backs and the steel supports at their sides. During construction, fall protection for riggers consisted of a safety belt and two lanyards equipped with clips to tie/clip off to the ladder rungs as they ascended or descended it. A cable climbing kit for self-retracting lifelines had not yet been installed behind the ladder as permanent fall protection. The ladder led to a pre-installed work platform at about 50 feet, where workers stood while bolting the tower sections together. See Figure 1. The platform's ladder opening, about 3-foot square, could be covered with a hinged metal cover after the platform was gained.

Except for ice on the bolt flange, which was removed, the tower's top section appeared clear. The top section was lifted into position, and the workers on the platform began bolting it into place. Four bolts were connected when the workers noticed more ice in the top section. They decided there was insufficient accumulation to warrant its removal; Coworker 1 climbed up its pre-installed ladder to dislodge it instead. A large chunk of ice fell to the platform and struck Coworker 2 on the head, knocking his hard hat off. Coworker 2 complained of feeling dizzy and the victim, also on the platform, notified crew on the ground that he and injured Coworker 2 were coming down; Coworker 2 descended the ladder first. Apparently, neither worker clipped off to ladder rungs during their descent. More large pieces of ice, estimated to be up to 1 foot square and 6 inches thick, suddenly let loose from the sides of the top section and fell through the platform's ladder opening onto the men on the ladder. The victim, above Coworker 2 on the ladder at between 20-40 feet, was struck by the ice and knocked from the ladder. As he fell, his head struck a steel ladder support and he sustained instant, fatal, head injuries.

Recommendation #2: Cap wind turbine tower sections exposed to inclement weather to avoid ice build-up inside.

Discussion: Tower sections were stored lying horizontally, open-ended, and unprotected on the ground prior to erection. Open ends could be securely capped with a tarpaulin or similar covering to prevent snow from entering during winter months. This procedure, in addition to eliminating the hazard which caused this incident, may actually save time during tower erection.
