Minnesota FACE Investigation 94MN01301

Construction Worker Dies After Falling From a Wind Turbine Tower

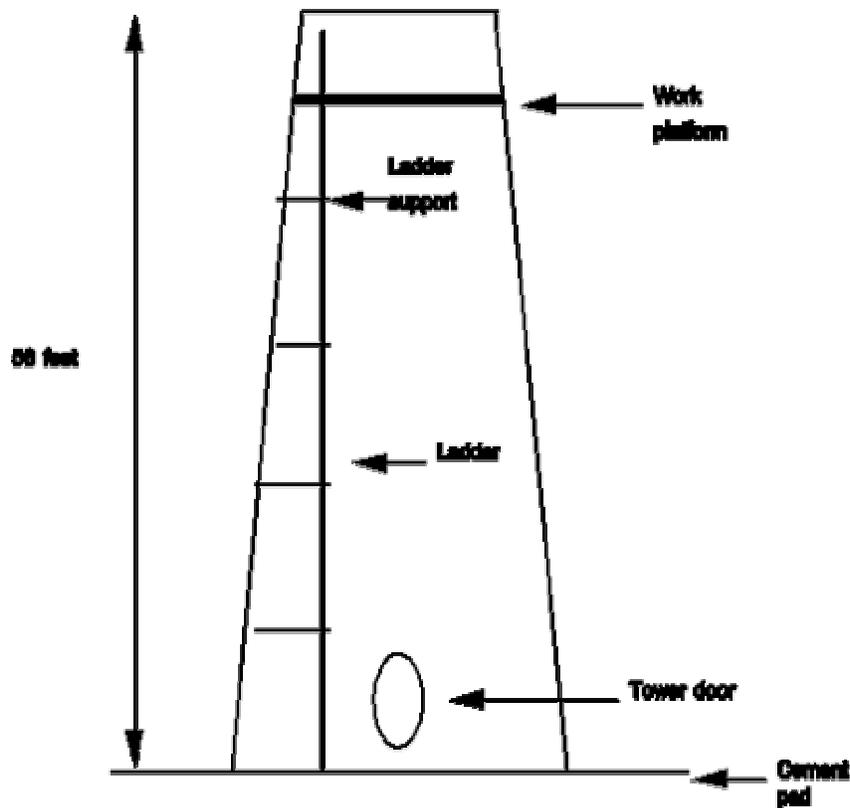
Figure 1.; Interior of bottom section of tower. Not to scale.

Except for ice on the bolt flange, which was removed, the tower's top section appeared clear. The top section was lifted into position, and the workers on the platform began bolting it into place. Four bolts were connected when the workers noticed more ice in the top section. They decided there was insufficient accumulation to warrant its removal; Coworker 1 climbed up its pre-installed ladder to dislodge it instead. A large chunk of ice fell to the platform and struck Coworker 2 on the head, knocking his hard hat off. Coworker 2 complained of feeling dizzy and the victim, also on the platform, notified crew on the ground that he and injured Coworker 2 were coming down; Coworker 2 descended the ladder first. Apparently, neither worker clipped off to ladder rungs during their descent. More large pieces of ice, estimated to be up to 1 foot square and 6 inches thick, suddenly let loose from the sides of the top section and fell through the platform's ladder opening onto the men on the ladder. The victim, above Coworker 2 on the ladder at between 20-40 feet, was struck by the ice and knocked from the ladder. As he fell, his head struck a steel ladder support and he sustained instant, fatal, head injuries.

Recommendation #1: Ensure workers use fall protection, even in emergency situations, when ascending/descending fixed ladders.

Recommendation #2: Cap wind turbine tower sections exposed to inclement weather to avoid ice build-up inside.
