TENNESSEE VALLEY AUTHORITY

KINGSTON FOSSIL PLANT

ANNUAL ASH POND DIKE
STABILITY INSPECTION
2008

Prepared by: Jamey Dotson
Date: February 15, 2008

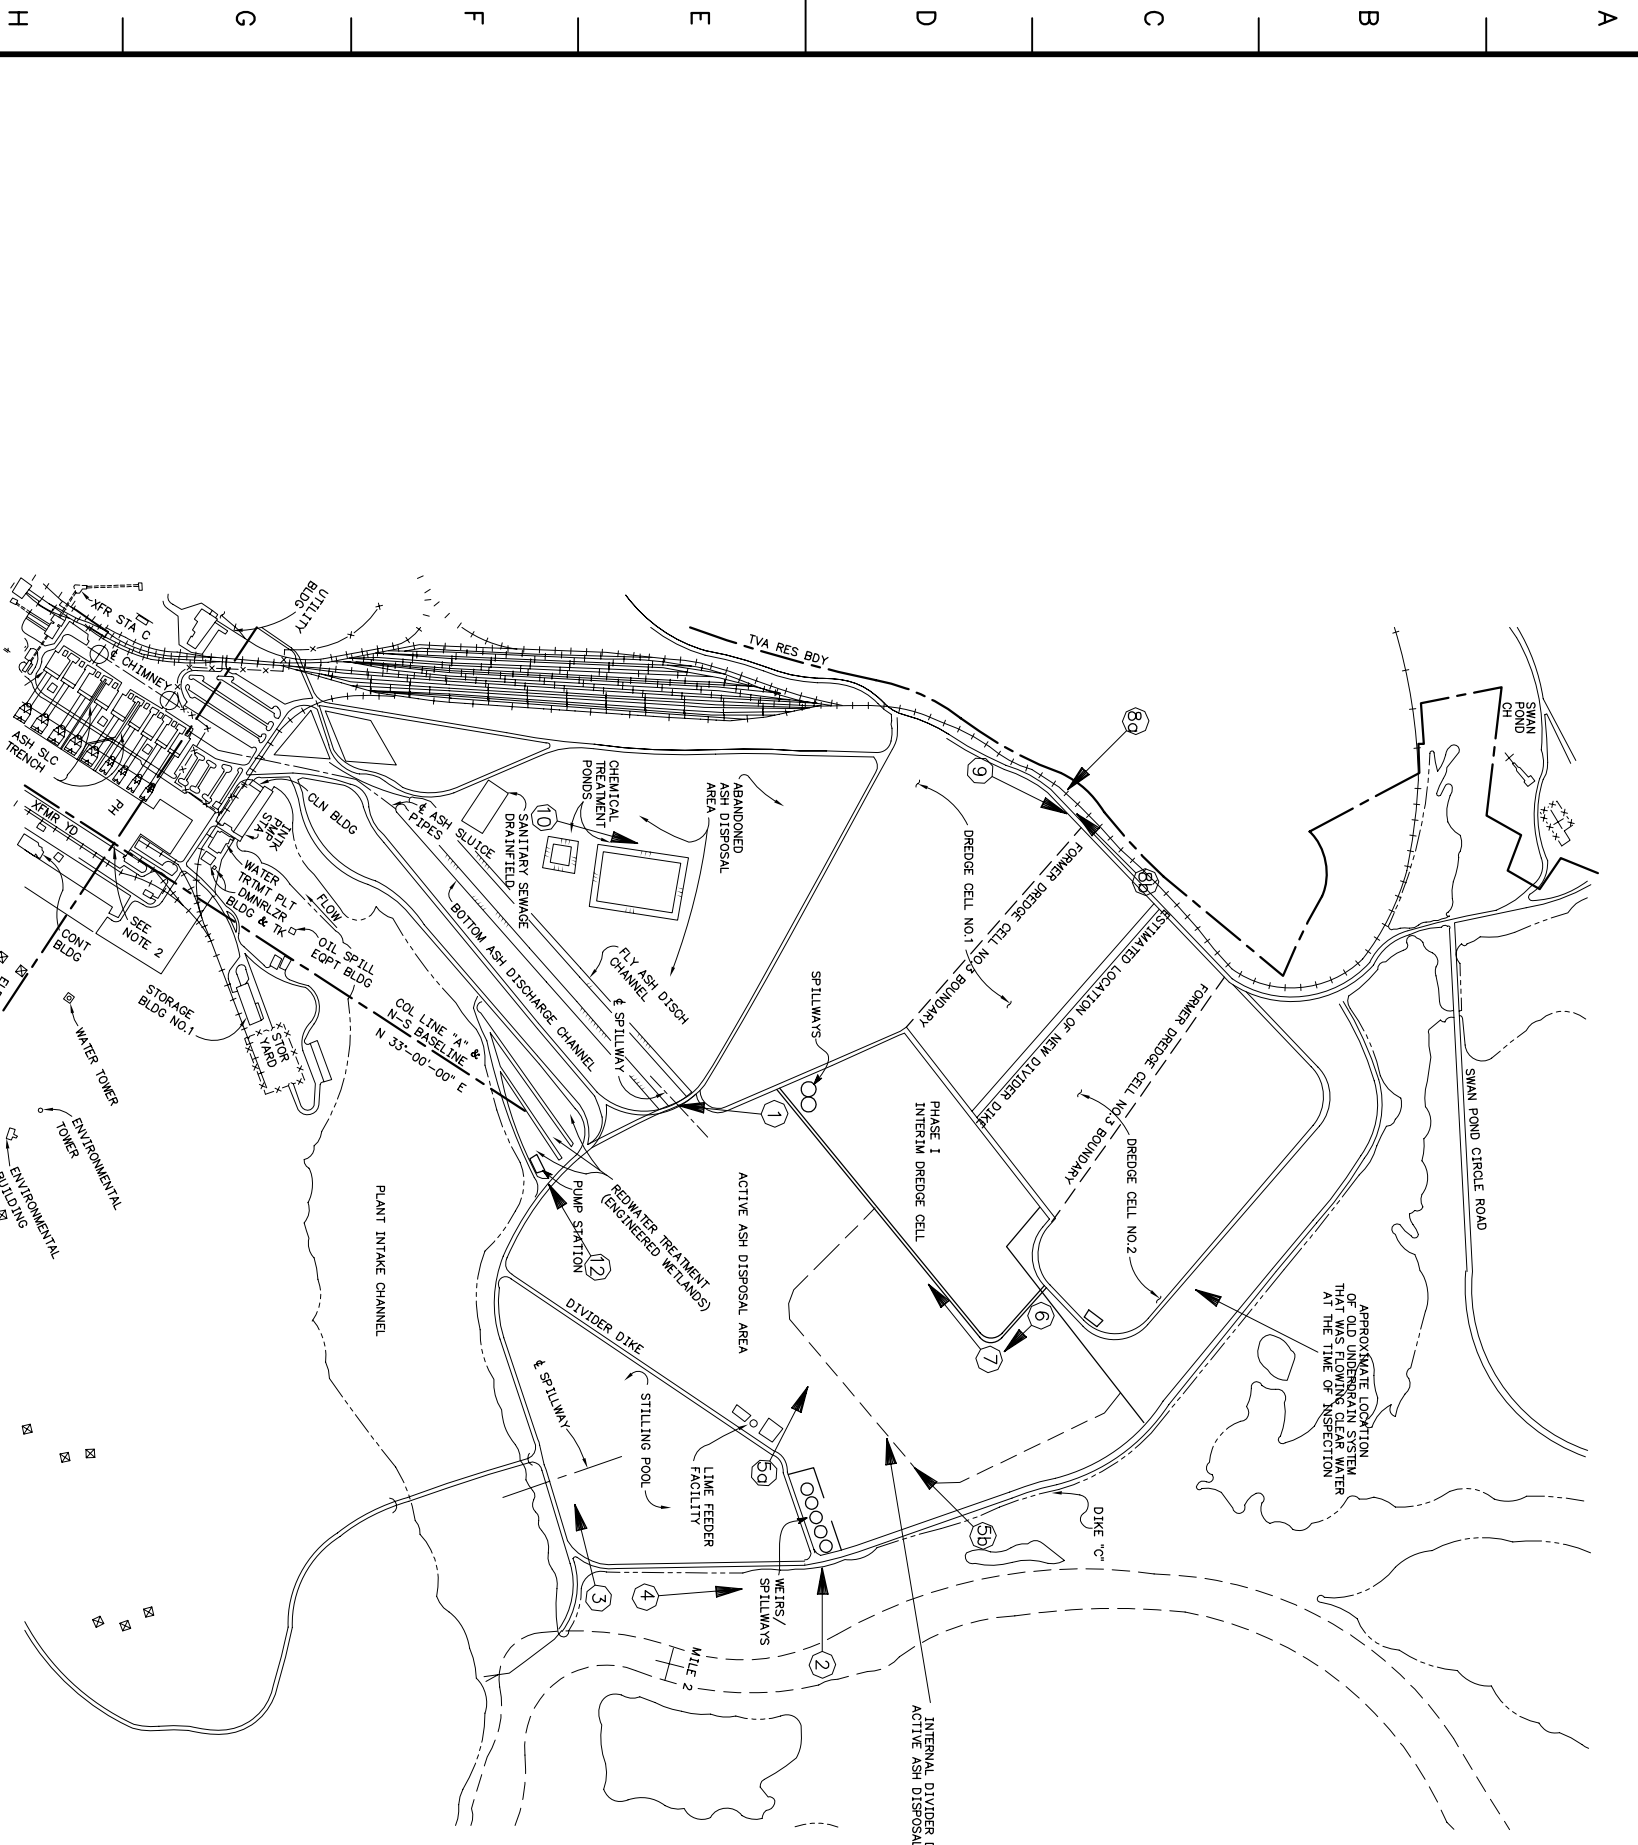
Fly ash is sluiced into an adjacent channel to the bottom ash channel where it flows into the main ash pond. The fly ash channel was cleared of vegetation last year. Both channels flow northeast into the active ash pond. See Figure 1 and drawing API 2008.
