**RAILWAY INVESTIGATION REPORT  
R13D0054**

**RUNAWAY AND MAIN-TRACK DERAILMENT**

**MONTREAL, MAINE & ATLANTIC RAILWAY  
FREIGHT TRAIN MMA-002  
MILE 0.23, SHERBROOKE SUBDIVISION  
LAC-MÉGANTIC, QUEBEC  
06 JULY 2013**

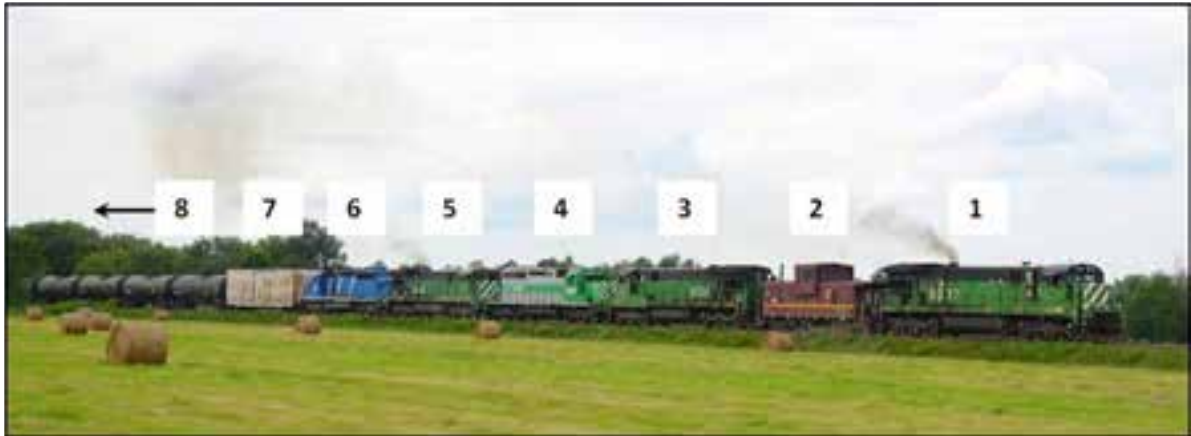
1. lead locomotive MMA 5017, General Electric Company (GE) C30-7;
2. special-purpose caboose (VB car) VB 1;
3. locomotive MMA 5026, GE C30-7;
4. locomotive CITX 3053, General Motors (GM) SD-40;
5. locomotive MMA 5023, GE C30-7;
6. locomotive CEFX 3166, GM SD-40;
7. buffer car CIBX 172032; and
8. 72 tank cars.

Photo 2. MMA-002 at Brookport on 05 July 2013 (photo: Richard Deuso, with TSB annotations)

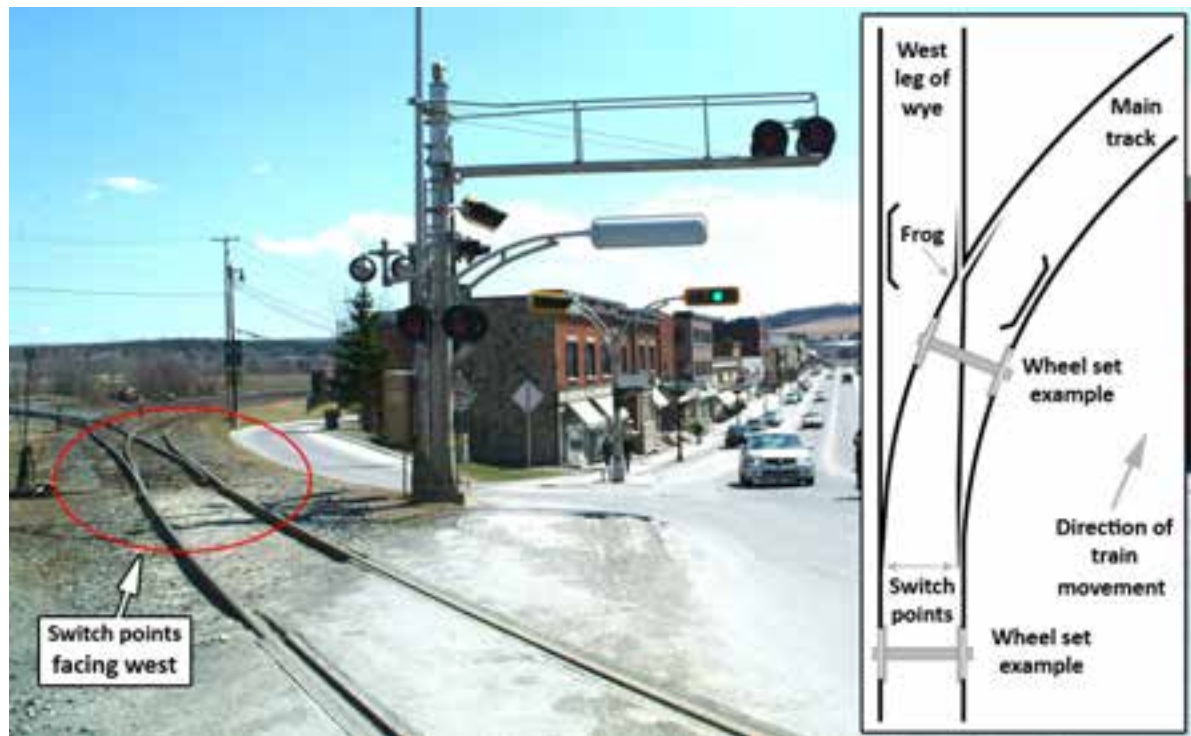
The MMA Megantic Station was located in a commercial district of Lac-Mégantic, where the Sherbrooke and Moosehead Subdivisions met. Frontenac Street, a main thoroughfare, ran through the centre of the town. The main track intersected with Frontenac Street just west of the Megantic West turnout and was maintained for a maximum speed of 15 mph. The turnout was located at Mile 0.23, with the switch points facing west (Photo 4).

Photo 4. Frontenac Street public grade crossing, looking eastward. The circled area denotes the location of the switch points and the frog for the Megantic West turnout (photo: Pierre Blondin, with TSB annotations).

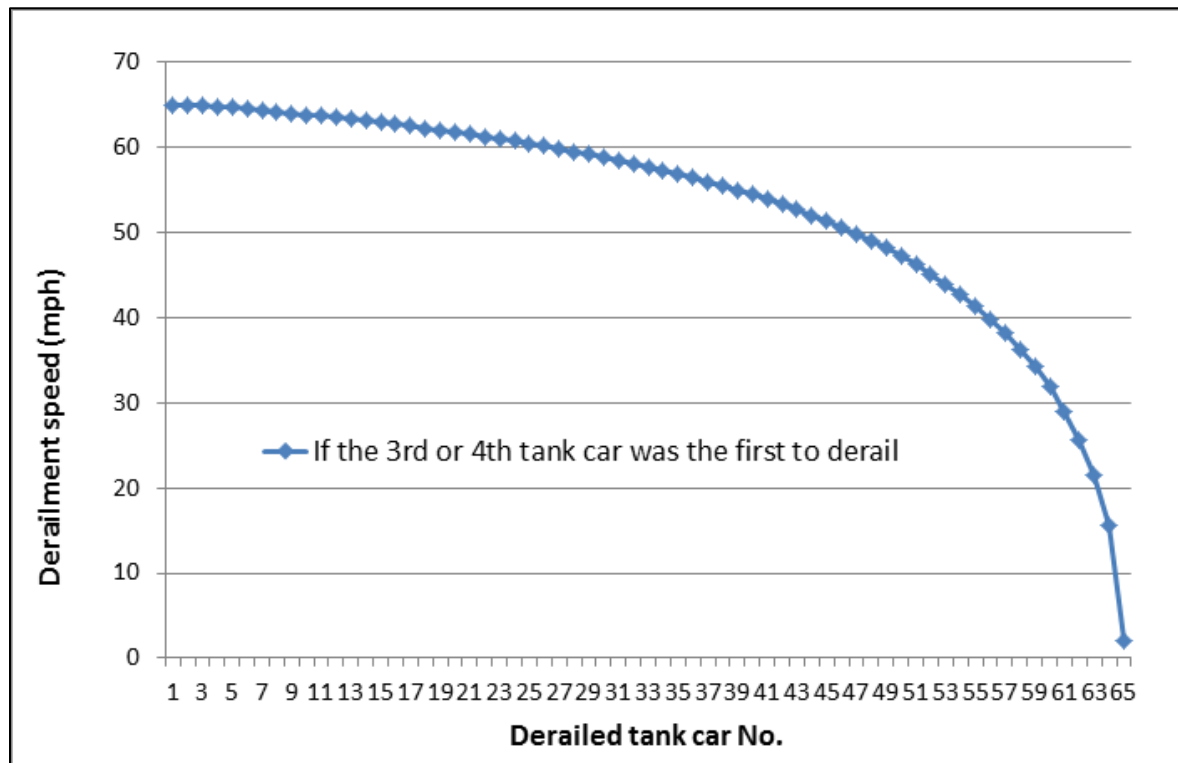
Figure 5. Estimated speed at which each car derailed if the third or fourth car was the first to derail<sup>32</sup>

At the time of the derailment, the train was near the Megantic West turnout. The train was analyzed to assess the in-train forces as it transitioned from the downhill grade of 1.26% to the relatively flat terrain of 0.2% at Megantic. A vehicle dynamics simulation of a Class 111 tank car negotiating the curve at Megantic Station was also conducted (see Engineering Laboratory Report LP188/2013 for complete details). It was determined that a combination of the centrifugal force and the dynamic forces generated by the track geometry conditions at a speed of 65 mph was sufficient to cause the derailment. With extremely high lateral forces on the high rail, gauge widening could occur. Furthermore, with complete unloading on the low rail, wheel lift could occur. Either of these conditions or a combination could cause track damage and a derailment.

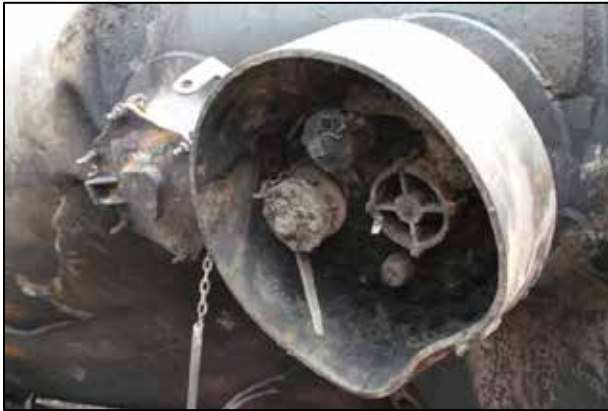
The top fittings of 32 of the 63 tank cars were housed in a  $\frac{3}{4}$ -inch-thick steel circular protective housing designed to provide top discontinuity protection in accordance with applicable AAR requirements<sup>40</sup> (Photo 21).

Photo 21. Protective housing providing top discontinuity protection for tank car fittings (removed cover)

- The top fittings were breached on 4 of the 27 cars (15%) that were equipped with top discontinuity protection housings and that sustained impact damage.
- The top fittings were breached on 16 of the 26 cars (62%) that were equipped with a hinged housing and that sustained impact damage.

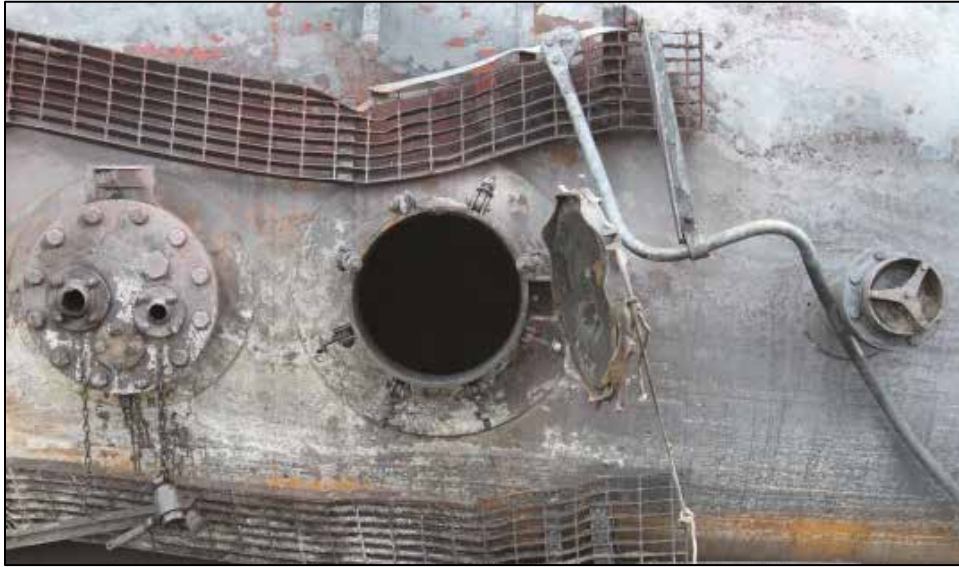
- The manway gaskets on most of the derailed tank cars were damaged by extended exposure to the post-derailment fire.
- The manway cover of 2 cars had separated as a result of impact damage.
- The manway cover hinges, bolts, or lugs of 22 tank cars exhibited impact damage that may have compromised their seals.

Photo 23. Manway cover and opening

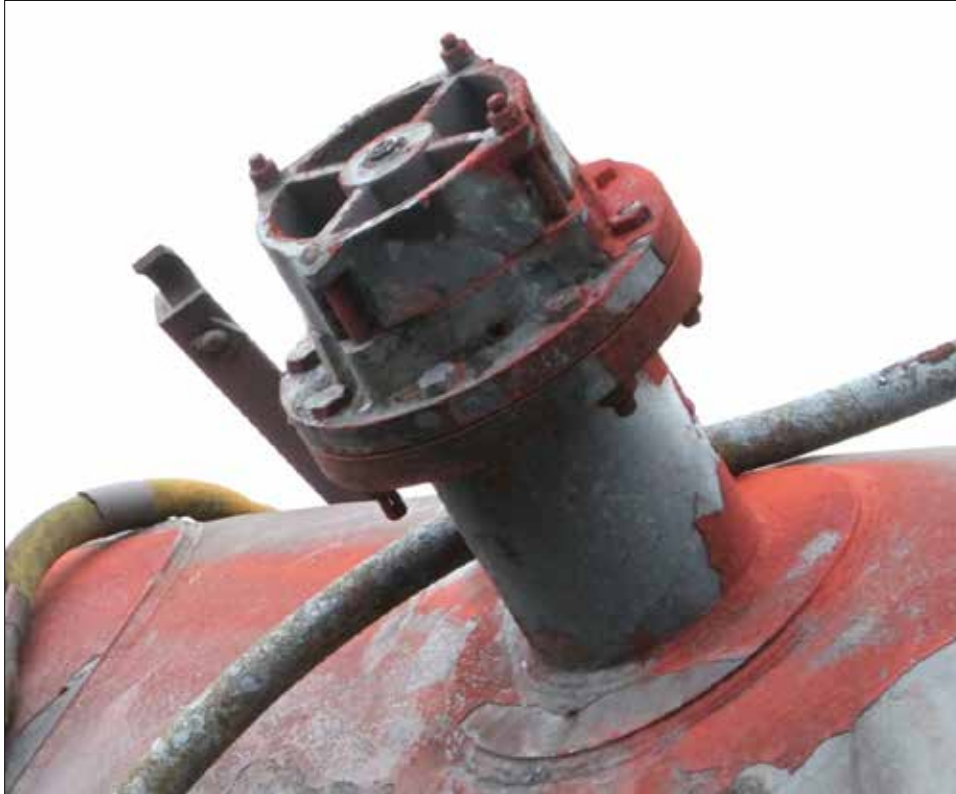
All 63 derailed tank cars were equipped with at least 1 reclosing pressure relief device (PRD),<sup>41</sup> as per the federal regulations.<sup>42</sup> The start-to-discharge (STD) pressure<sup>43</sup> of these PRDs was either 75 psi (on 48 tank cars) or 165 psi (on 15 tank cars). In addition to different STD pressures, PRDs are designed with different flow capacities.<sup>44</sup> A PRD that can discharge product at greater than 27 000 cubic feet per minute (CFM) is considered to have high flow capacity. In this accident, 13 of the 15 PRDs with STD pressure of 165 psi had flow capacities of about 38 900 CFM.

Photo 24. Pressure relief device

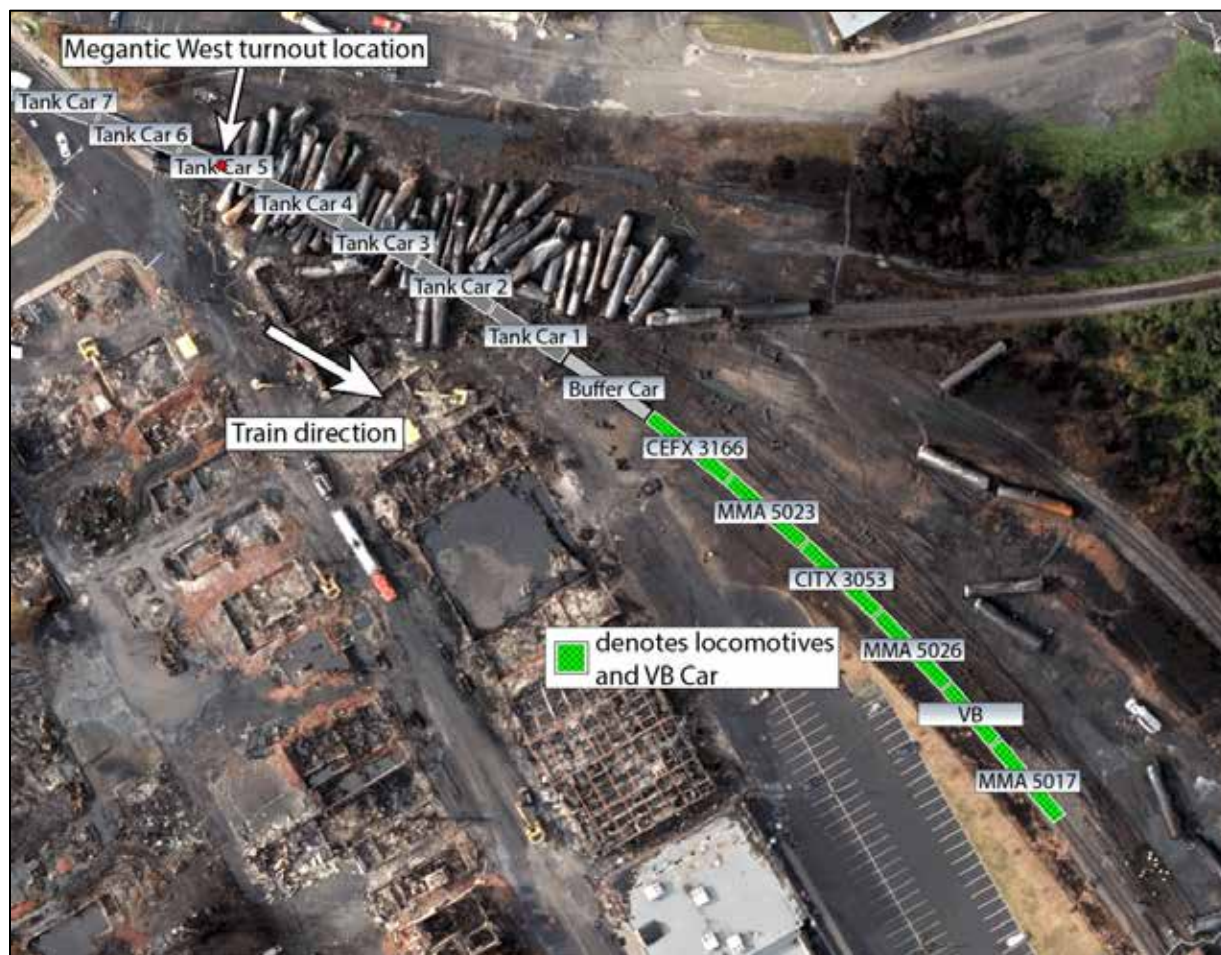
The general trajectory of the derailed equipment also confirmed that the point of derailment (POD) was at or near the Megantic West turnout. To determine which cars were most likely the first to derail, the TSB analyzed LER information to establish the locations of the cars when the brake pipe pressure dropped to zero, as this indicated the moment of separation caused by the derailed equipment. Results show that tank cars 4 through 6 were closest to the POD at that time (Photo 29).

Photo 29. Location of the train when the brake pipe pressure dropped to 0 psi (sources: AeroPhoto and locomotive event recorder data)

An examination of the damage and of the final resting locations of the first derailed cars, starting from the front of the train, allowed the investigation to conclude that the derailment most likely occurred ahead of the sixth tank car.
